**DAMAGE SURVEY AND RESTORATION OF M/V WELLWOOD
GROUNDING SITE, MOLASSES REEF,
KEY LARGO NATIONAL MARINE SANCTUARY, FLORIDA**

J. H. HUDSON and R. DIAZ

U. S. Geological Survey, Fisher Island Station,
Miami Beach, Florida USA 33139

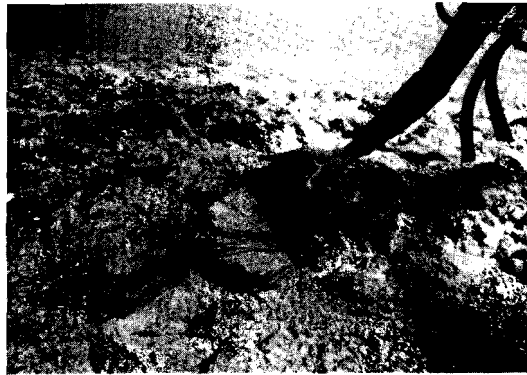
Figure 4. Fractured reef framework exposed by storm surge from Hurricane Kate.

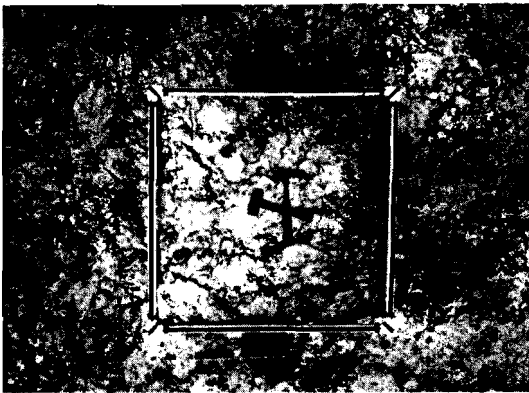
Figure 6. Section of fractured reef framework selected for cement grouting. PVC frame is 1 m². Nylon transect line is below frame.

Upon completion of the damage survey, pilot studies were conducted at the WELLWOOD grounding site between July and September 1985 to test the feasibility of stabilizing fractured reef framework, transplanting hard and soft corals into the major damage area, and rebuilding reef topography. A 1-m² area of fractured reef framework (figure 6) was restabilized by grouting with quick-setting underwater cement (figure 7). Removal of loose sand, gravel, and attached algal epiphytes from the site was necessary in order for the cement to bond properly. One bag (94 lbs or 43 kg) of Type II Portland grey cement and 10 lbs (4.5 kg) of molding plaster were used to grout in the damaged 1-m² area.

Cement is prepared by adding, by volume, 8 parts Portland Type II cement to 2 parts molding plaster. After combining dry ingredients thoroughly, add only enough (fresh or salt) water to achieve a consistency of firm putty. The cement should be applied immediately as it begins hardening 3 to 6 minutes after mixing. Latex or neoprene-coated gloves should be worn by diver and mixer to protect the skin from lime cement.

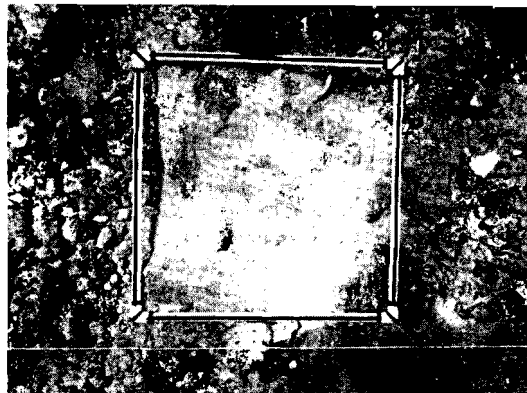
Figure 7. Freshly grouted 1-m² test plot.

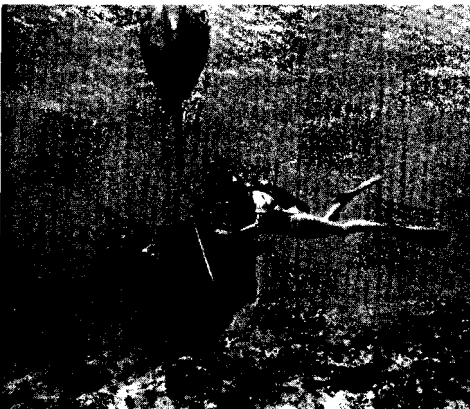
Figure 8. Airlift bags support a healthy grounding-dislodged head of *Montastraea annularis* that will be used to rebuild reef topography flattened by hull of the WELLWOOD.

A partial reconstruction of bottom relief in areas flattened by the hull of the WELLWOOD is being accomplished by divers using airlift bags to move large (1 m+), intact head corals (figure 8) and sections of dislodged reef framework back into areas of the reef that were swept clean by the hull. Once in place, each mass of coral is cemented permanently to the reef framework (figure 9).

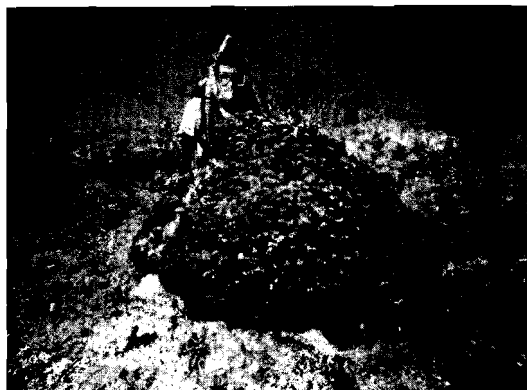
Figure 9. Newly transplanted *Montastraea annularis* (shown in figure 8). Note fresh cement (light areas) at base of colony.

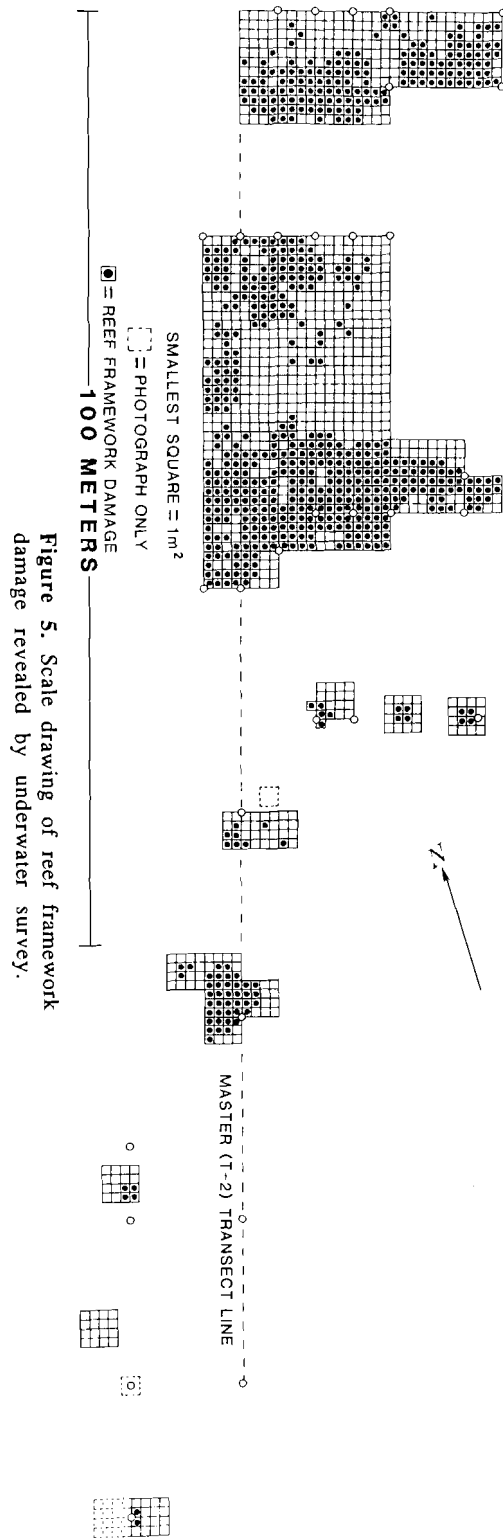
This survey covered 1,282 m² of substrate at the WELLWOOD grounding site on Molasses Reef (figure 5). Of this amount, 644 m² (50 percent) was found to have sustained reef framework fracture damage as previously described. Only where the WELLWOOD came to rest and exerted considerable downward pressure on the reef does there appear to be widespread observable fracturing. Fractured substrate is estimated to have incurred a 90 to 100 percent loss of live coral cover. The remaining 638 m² of framework surveyed (50 percent), although intact, sustained an estimated 70 to 90 percent loss of living coral. Photographic documentation of the surveyed area amounted to 342 5" x 7" black-and-white photographic prints, each covering a 4-m² portion of each 16-m² quadrat.

Figure 5. Scale drawing of reef framework damage revealed by underwater survey.

It is clear that reef framework fracture damage reported here is confined primarily to elevated segments of the substrate that lay beneath and supported the ship after she came to rest. Thus, damage shown in figure 5 is, in effect, a topographic map of sheared-off and flattened reef projections that bore the major impact and great weight of the stranded vessel. This 644-m area of Molasses Reef is not presently suitable for long-term recolonization by either hard or soft corals.
