## RADAR PREFLIGHT CHECKLIST

SEP 6 1980

FLIGHT # 19800906I1 - RADARA.C. # 43RFOPERATOR Lewis / MarksRADAR TECH GoldsteinNUMBER OF DIGITAL MAGNETIC TAPES ONBOARD 40NUMBER OF VIDEO <sup>Cassettes</sup> ~~TAPES~~ ONBOARD 6NUMBER OF TAPE LABELS ON BOARD 100

# NHEML RADAR TAPE LOG

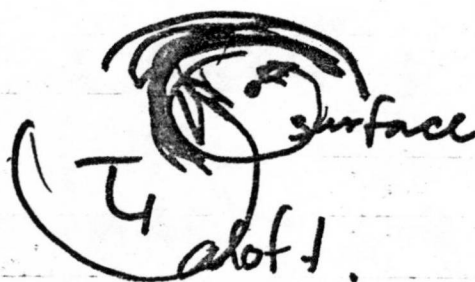
- 122130 LF to sector mode  $125^{\circ}$  center on  $+10^{\circ}$  elev. same as we did earlier, to compare with TA  
1227-229 good strong echoes  
123145 sector mode  $120^{\circ}$  center on  $180^{\circ}$   
appears to be a shadow  
123200 elev. to  $+5^{\circ}$

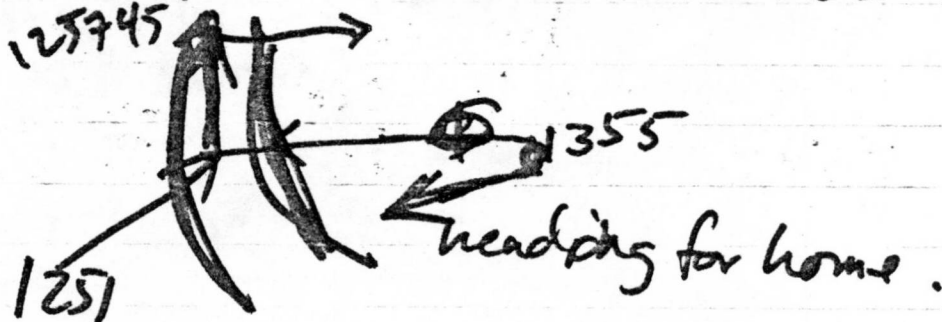
- 123900 back to continuous on LF  $22^{\circ}$  elev.  
1251 turn north in between rain bands

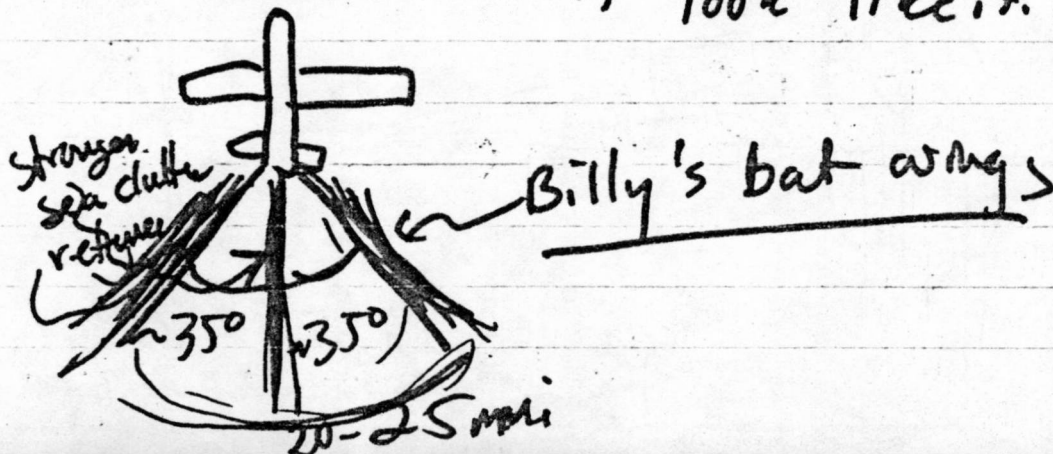
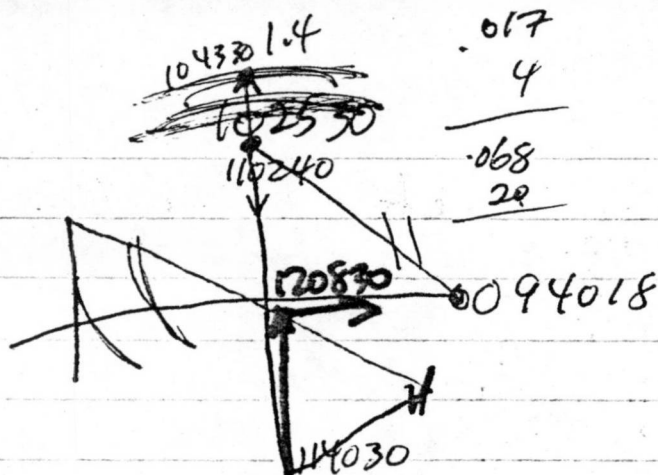
→ IS THERE A SHADOW BEHIND the ac?  
on LF it look like it.

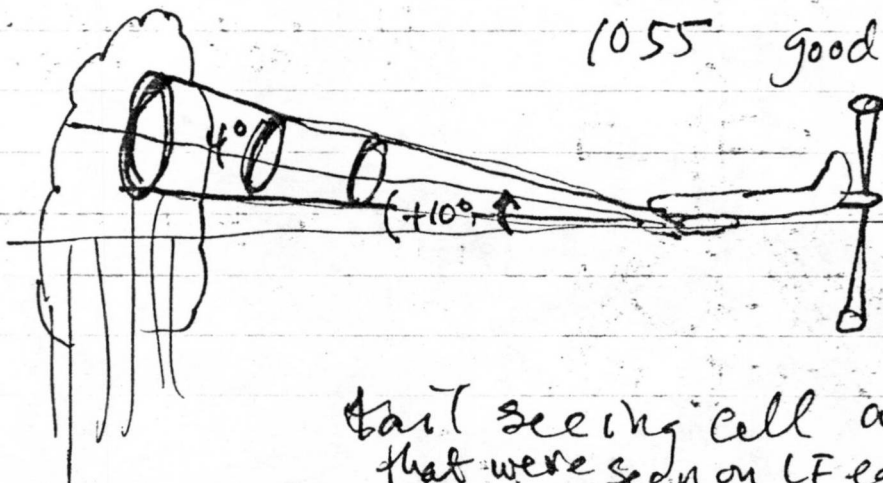
tail seeing cell at 105730-105800 that were seen on LF earlier
