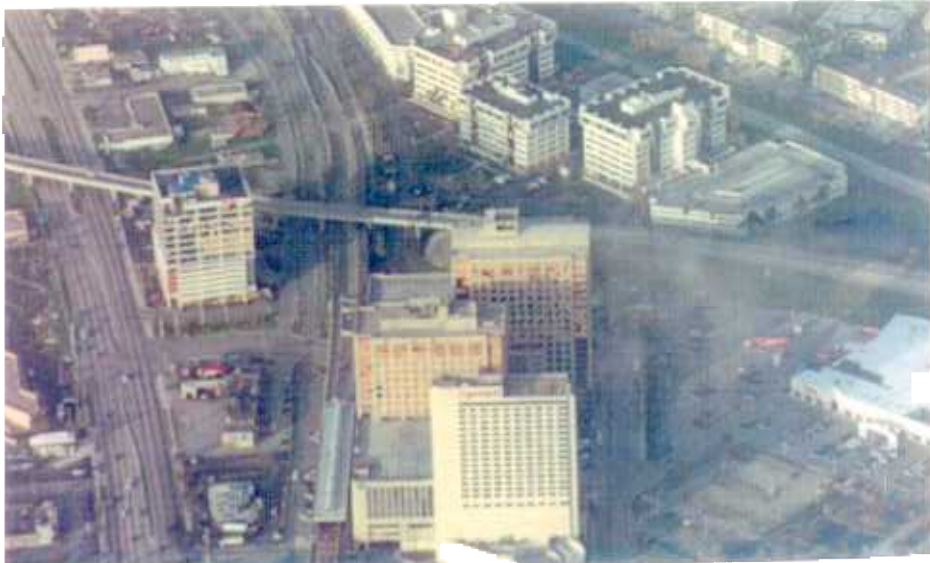
1. Broken window glass (boarded windows) downwind of Marriott Hotel in Coral Gables. View looking south-west along Highway 1.

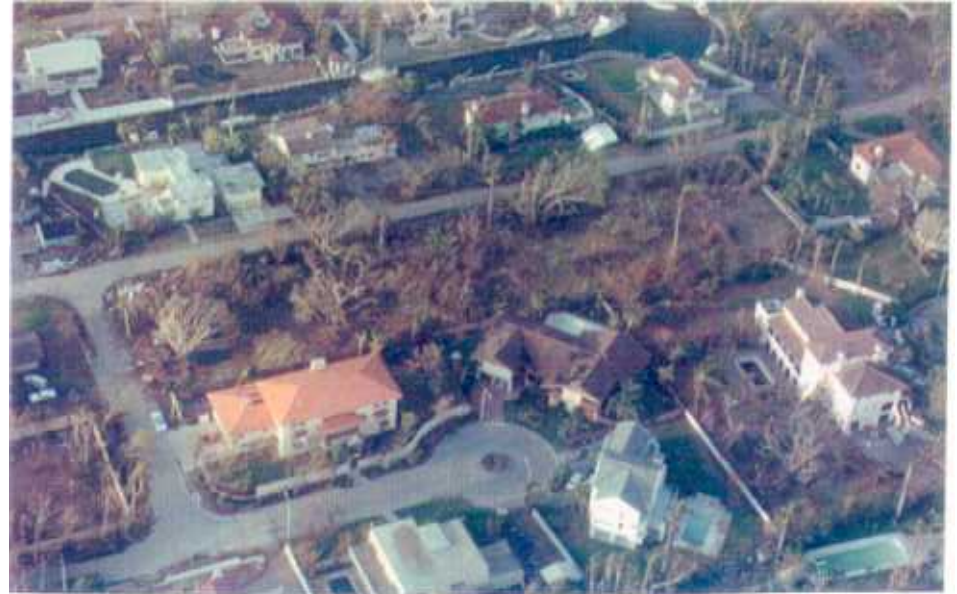
2. Minor roof damage to residences in Coral Gables.

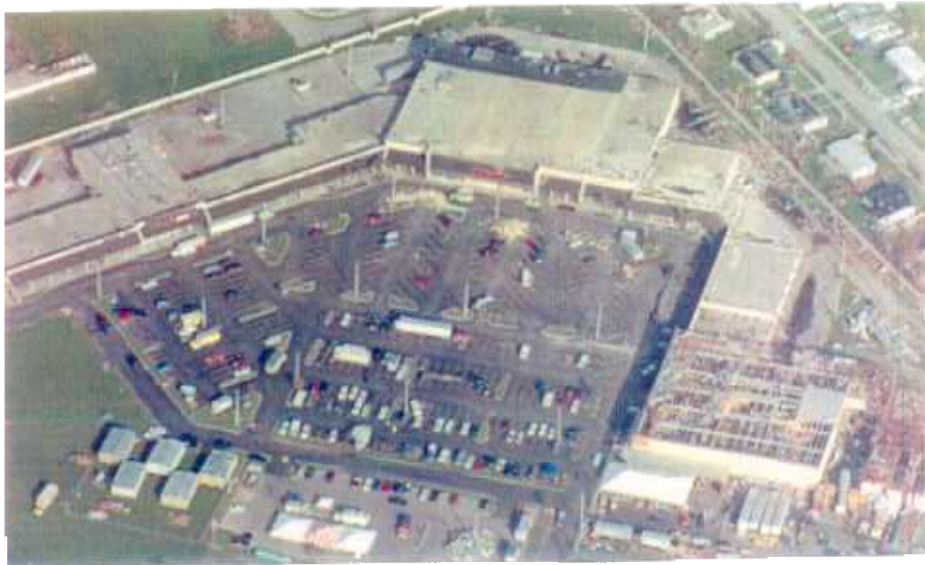
3. Partial loss of roof and metal decking in shopping center along Highway 1 near Perrine. View looking northwest.

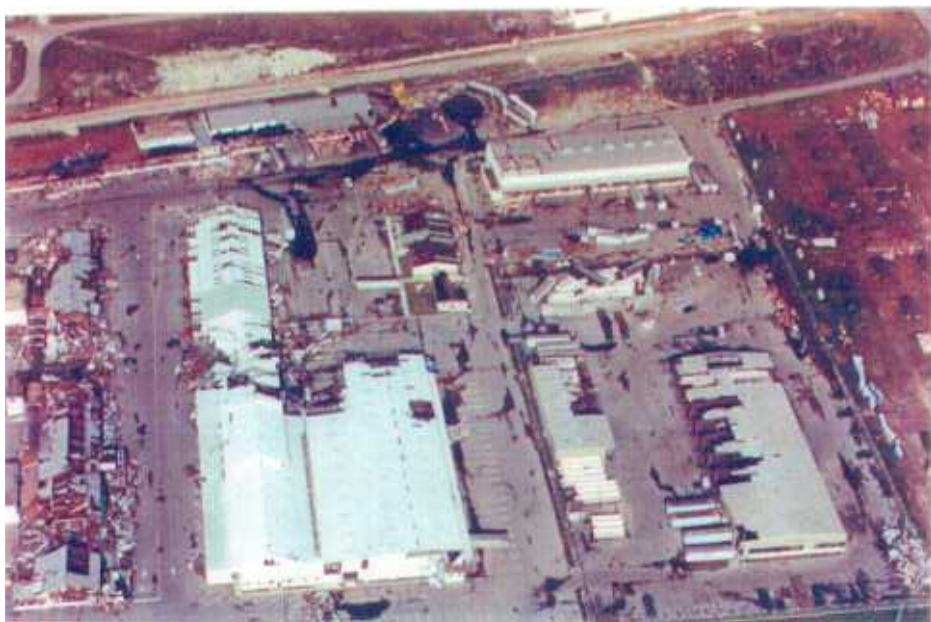
5. Metal building damage along Highway 1.  
View looking west.

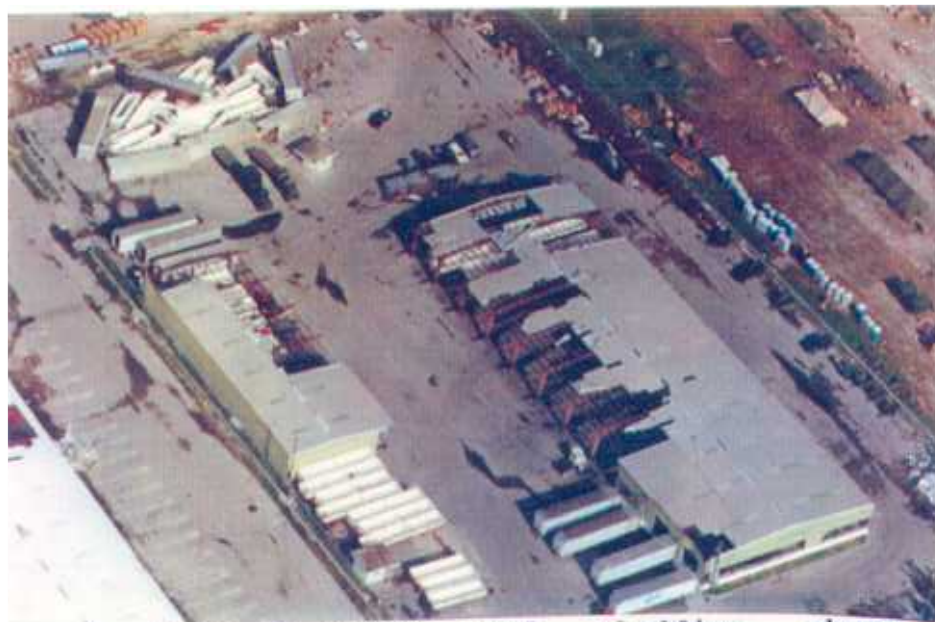
6. Loss of metal roof cladding above  
loading bay doors. View looking northwest.

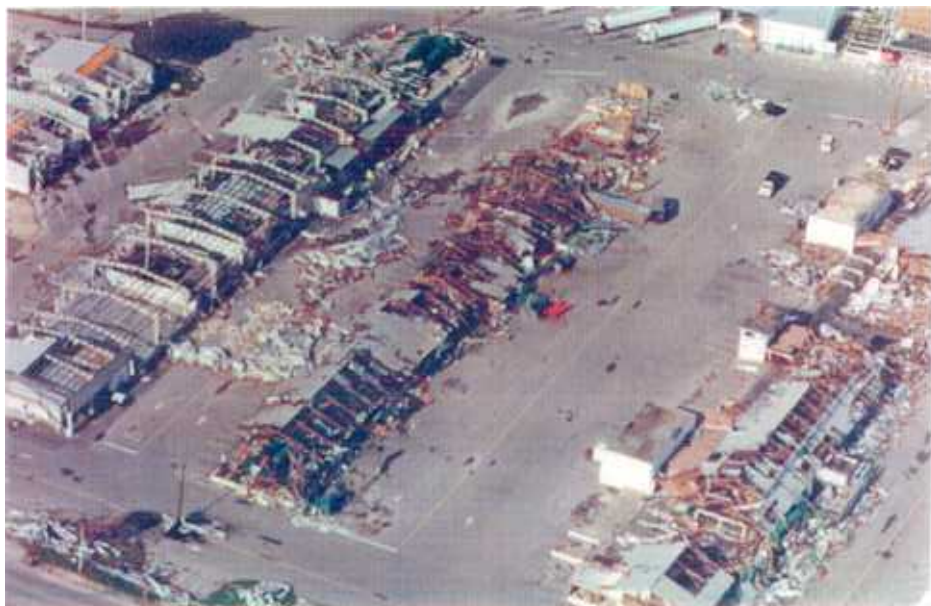
7. Loss of cladding and several collapsed  
bays in metal buildings along Highway 1.

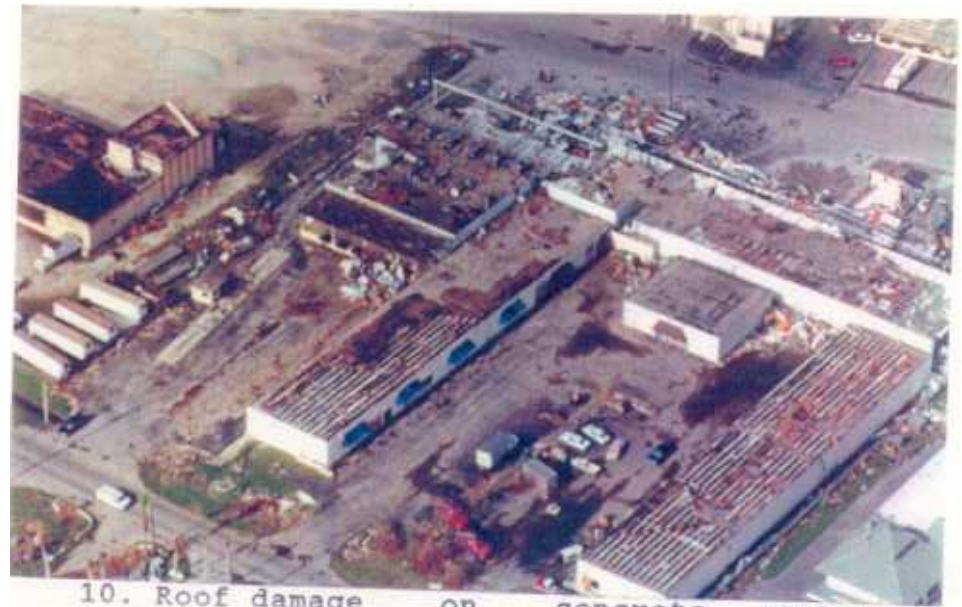
10. Roof damage on concrete masonry building in Homestead. View looking southwest.

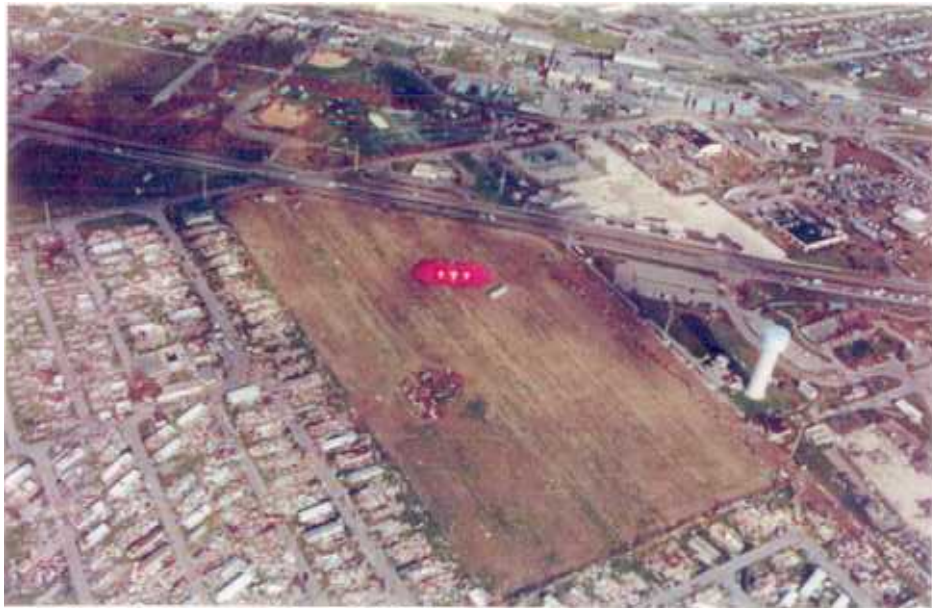
11. Destroyed mobile home part in Homestead adjacent to undamaged metal water tower.

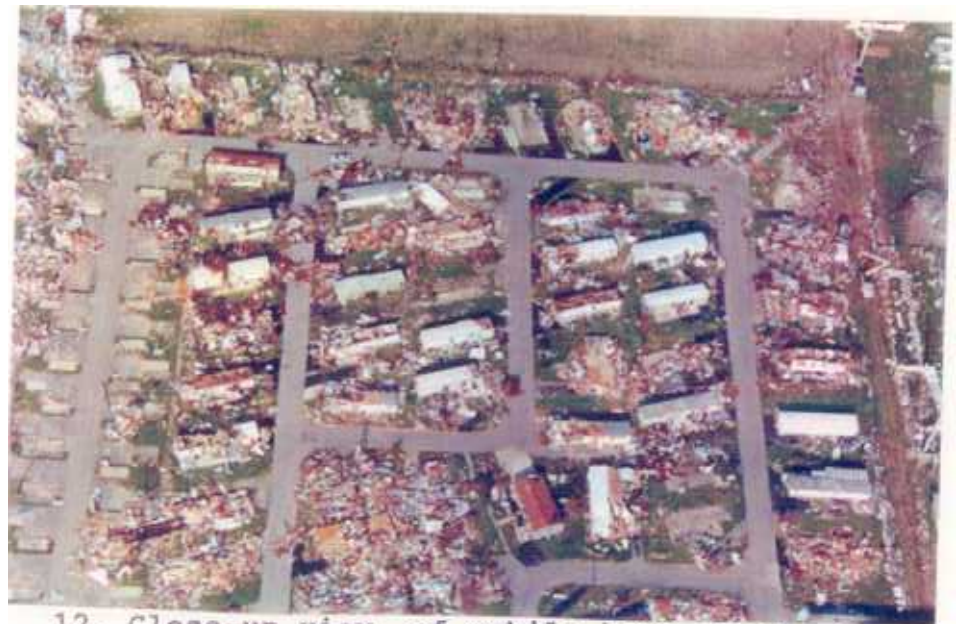
12. Close-up view of mobile home park in Homestead. View looking west.

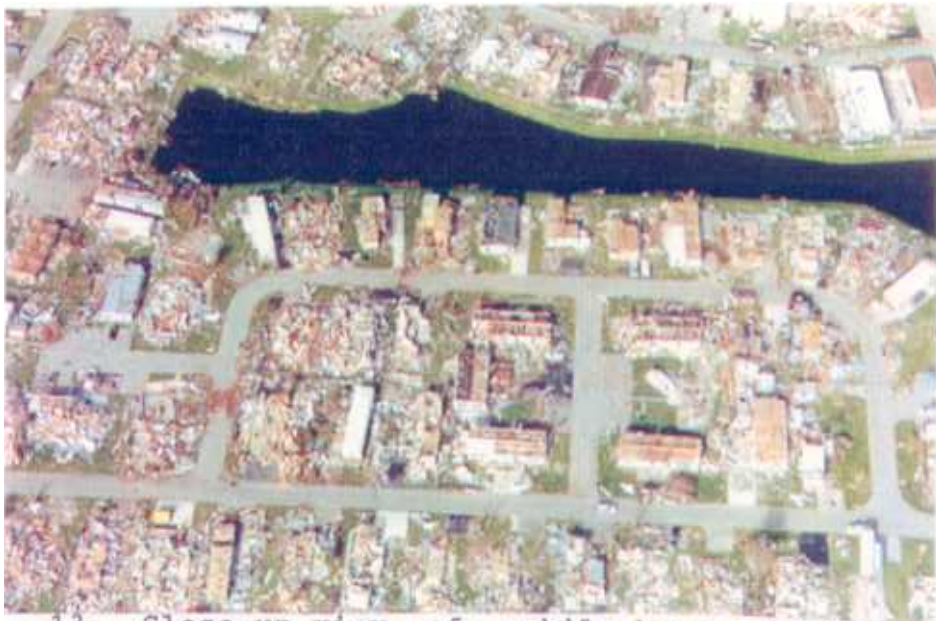
13. Close-up view of mobile home park in Florida City, looking west.

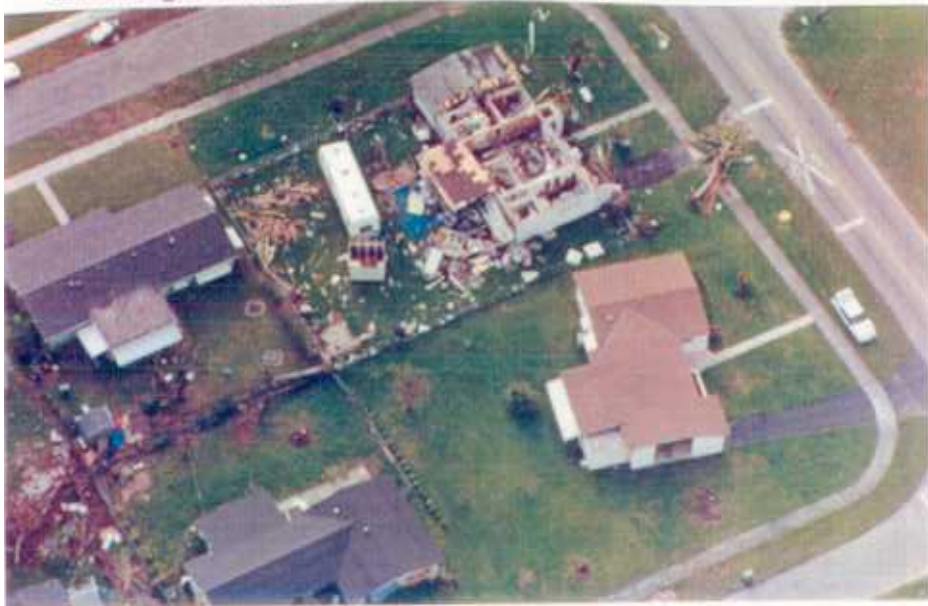
16. Removal of roof deck exposed wooden trusses on concrete masonry homes in Florida City.

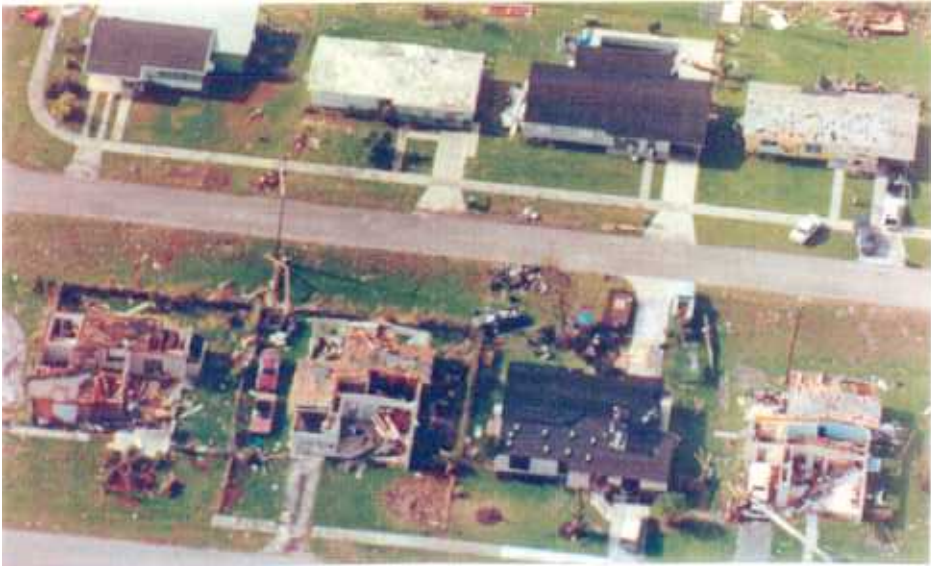
17. Residence damage (F0 to F2) which likely initiated in carport area. View looking south in Florida City.

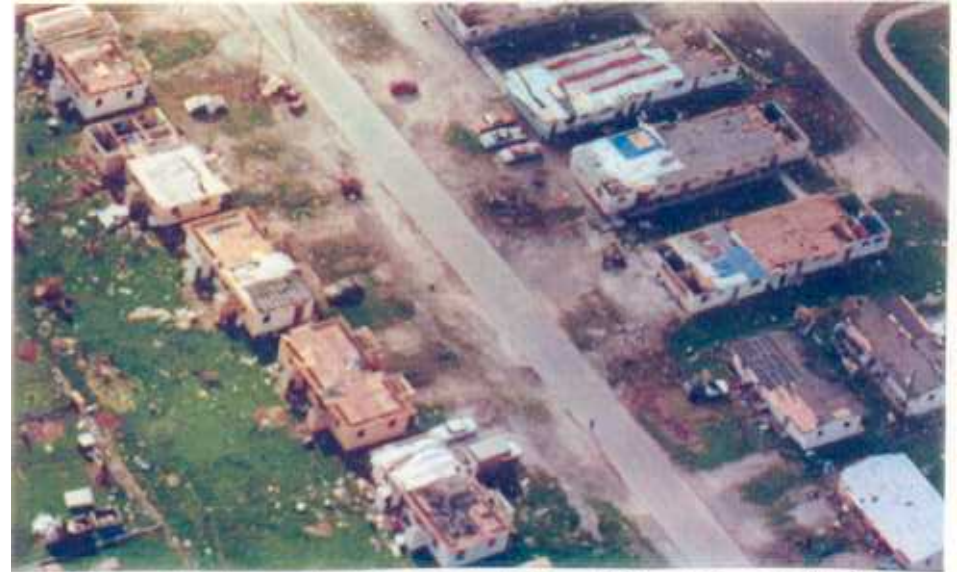
18. Flat roof damage (to F2) on multi-family dwellings in Florida City. View looking southeast.

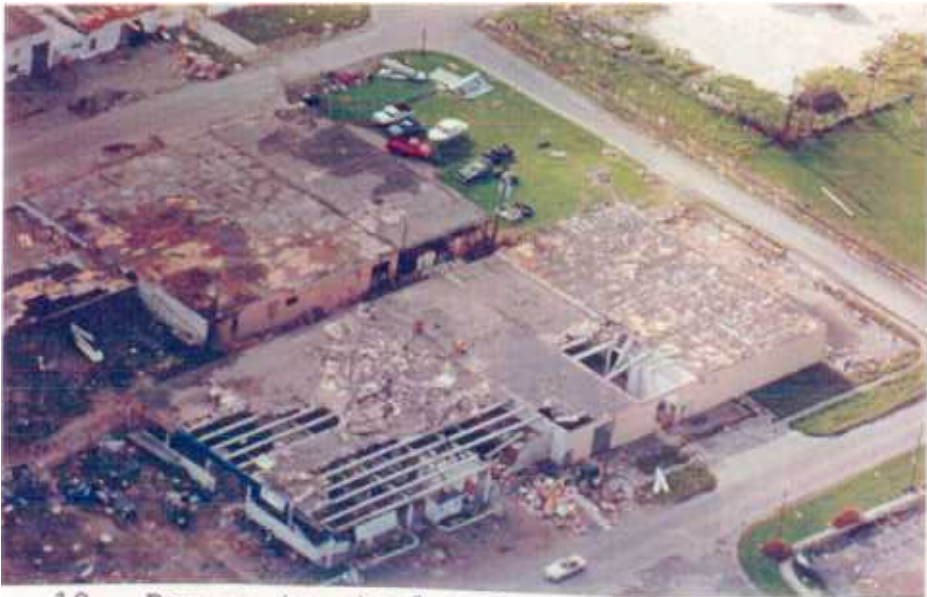
19. Damage to steel and concrete warehouse building in Florida City looking southeast.

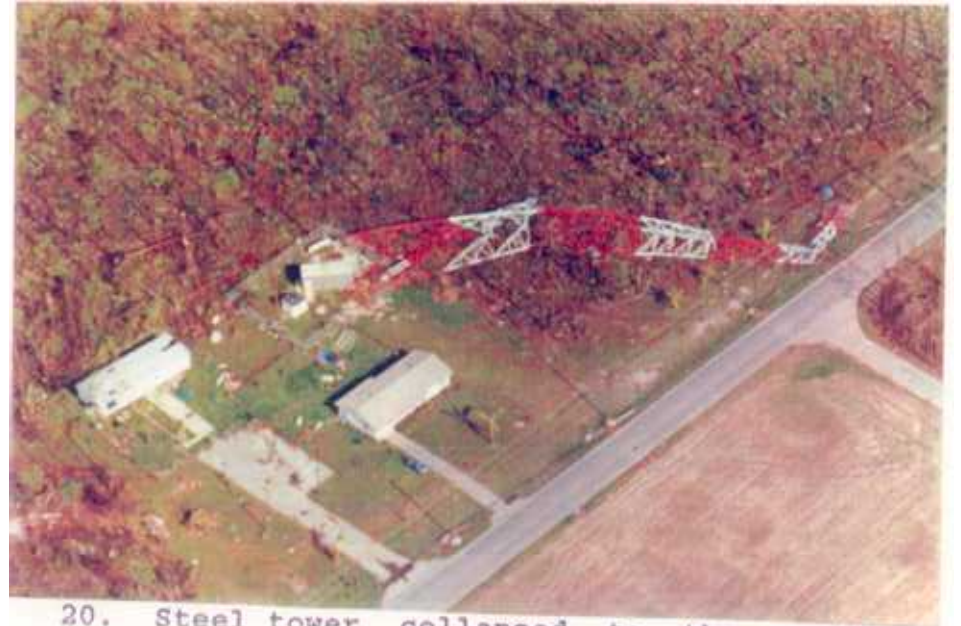
20. Steel tower collapsed to the north near Florida City.

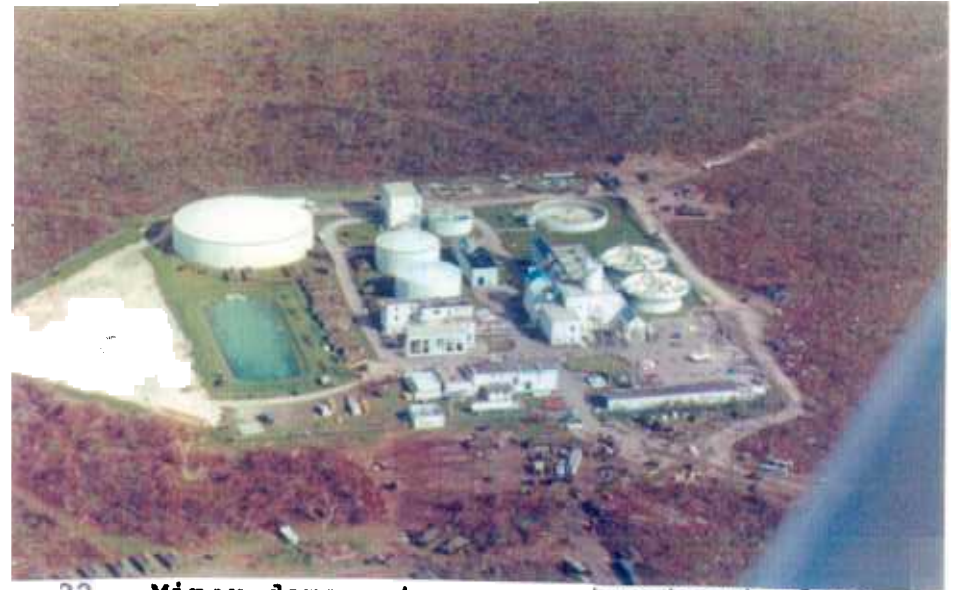
22. Minor damage to sewage treatment plant in rural Redlands. Concrete tanks remained undamaged.

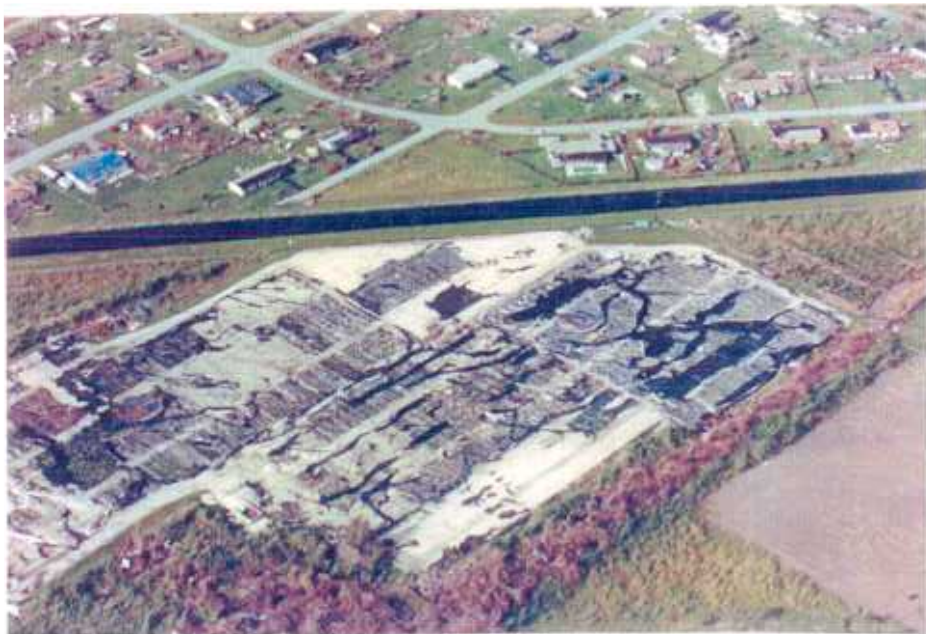
23. Damage to nursery and adjacent housing.

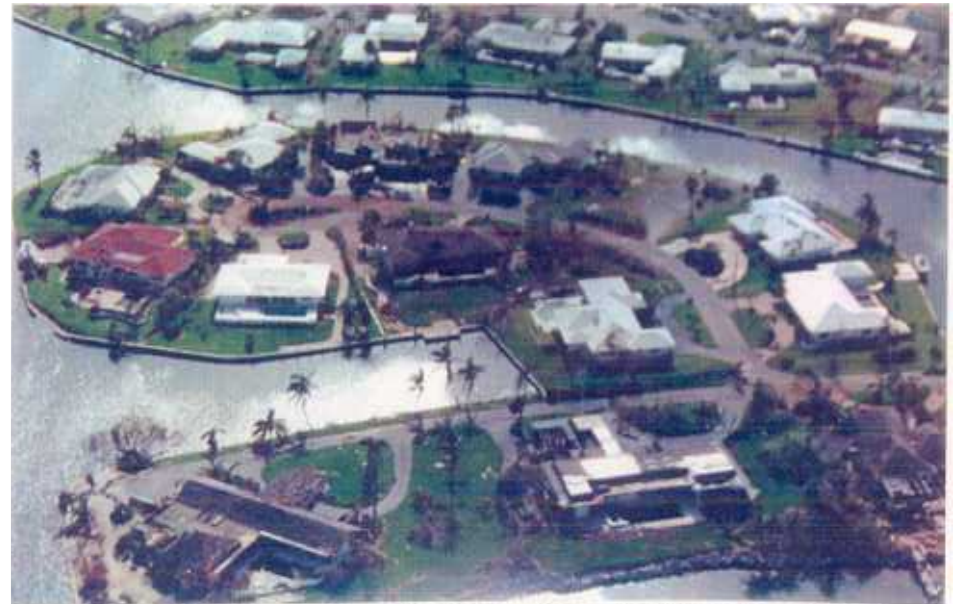
24. Minor roof damage to homes in Ocean Reef community on Key Largo.

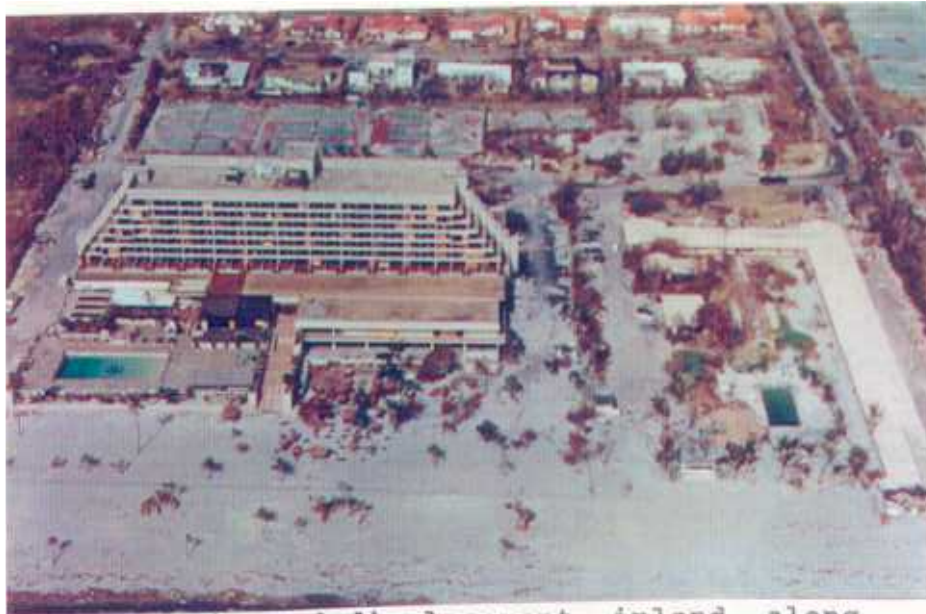
25. Beach sand displacement inland along shoreline of Key Biscayne.

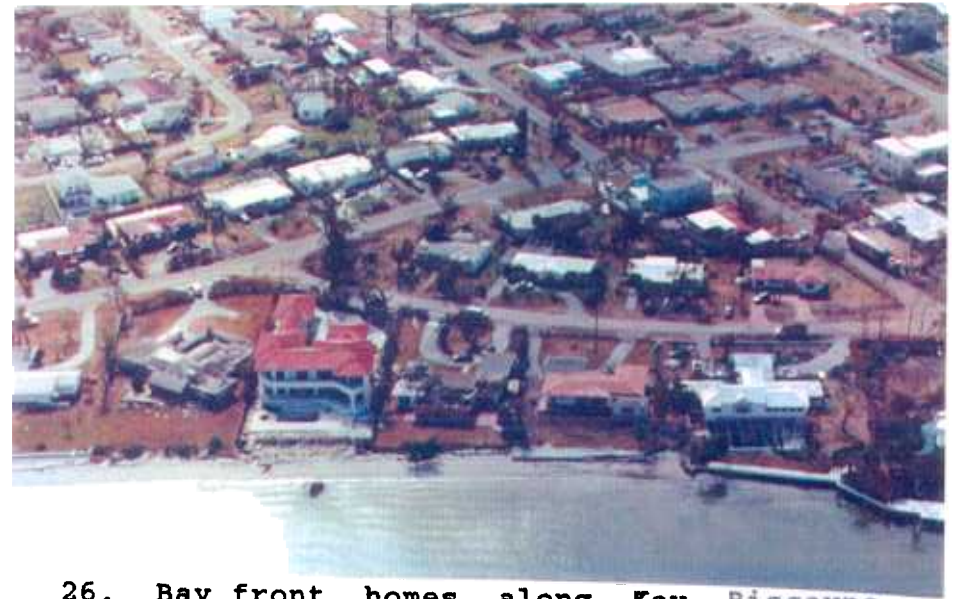
26. Bay front homes along Key Biscayne remained intact. Only minor roof and surge damage was noted.

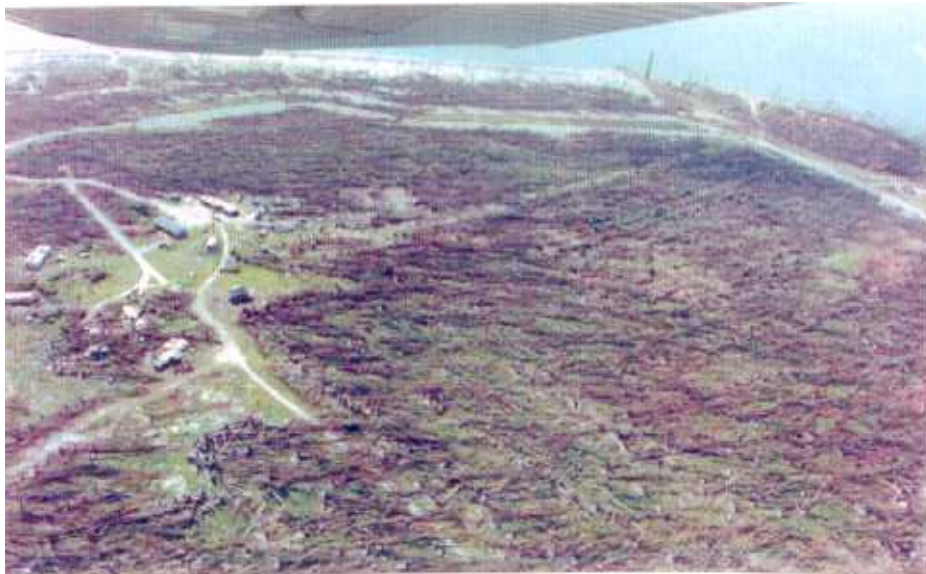
27. Flattened forest at southern end of Key Biscayne. Few trees were left standing.

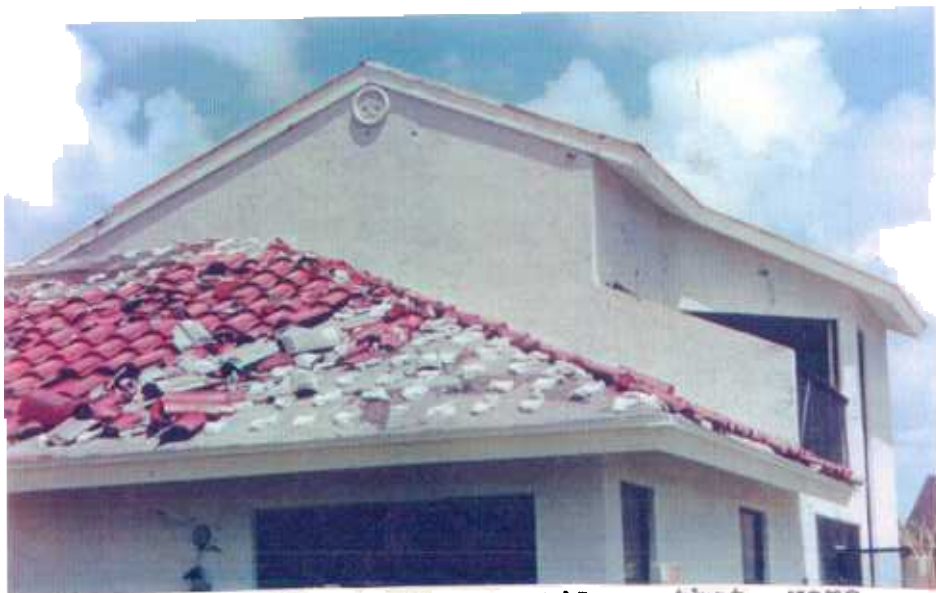
29. Damage to concrete tiles that were secured with mud (mortar). Failure occurred between the mud and the tile.

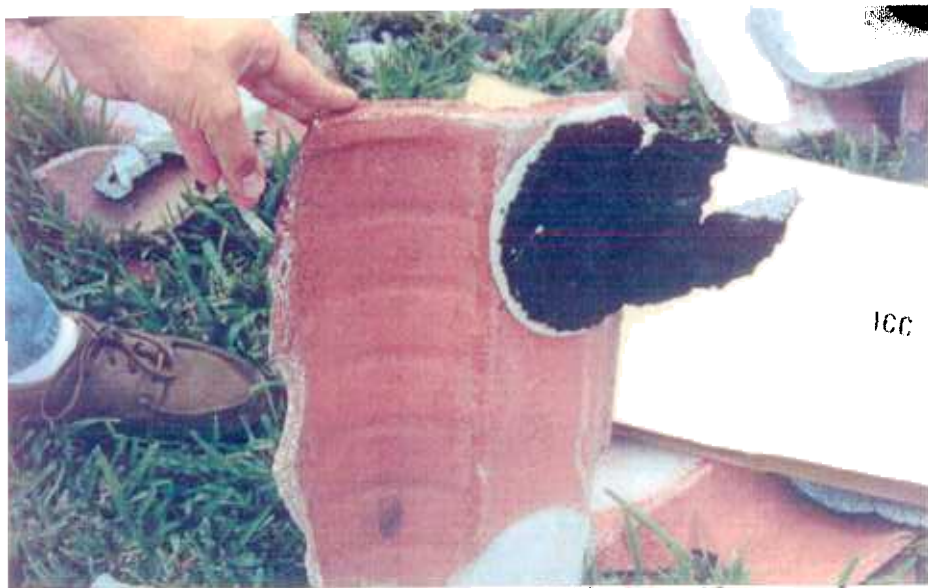
30. Tiles which did not bond well to mud. Note the offset between mud placement and the tile on the leftmost tile (Homestead).

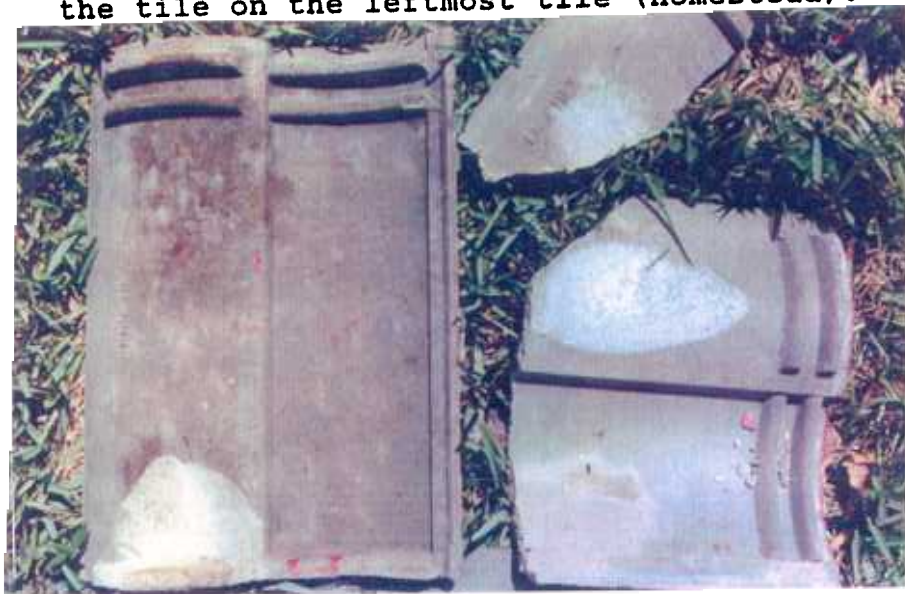
31. Tiles that bonded well to the mud failed along the roll roofing underlayment (Homestead).

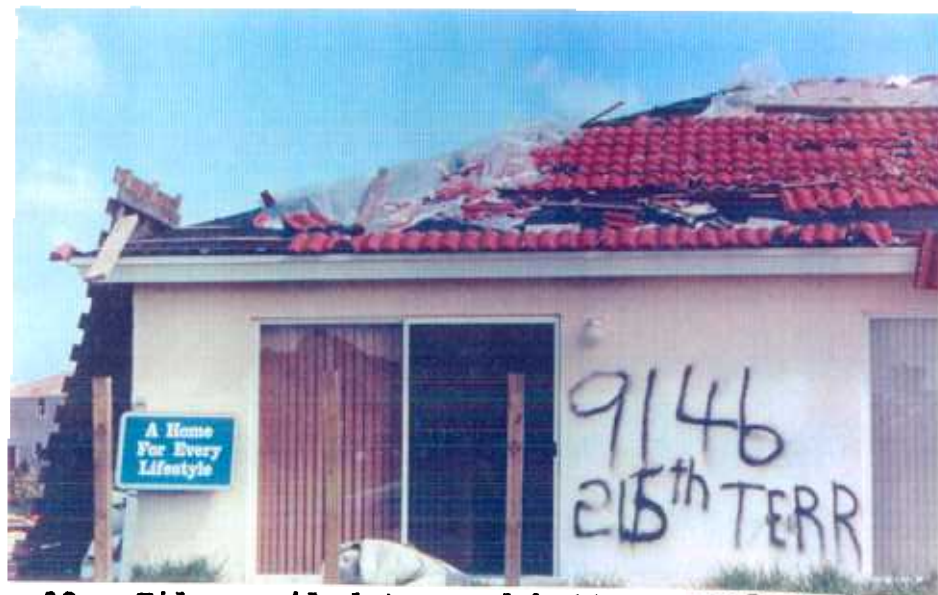
32. Tiles nailed to wood battens performed just as poorly as tiles that were mudded to roll roofing (Saga Bay area).

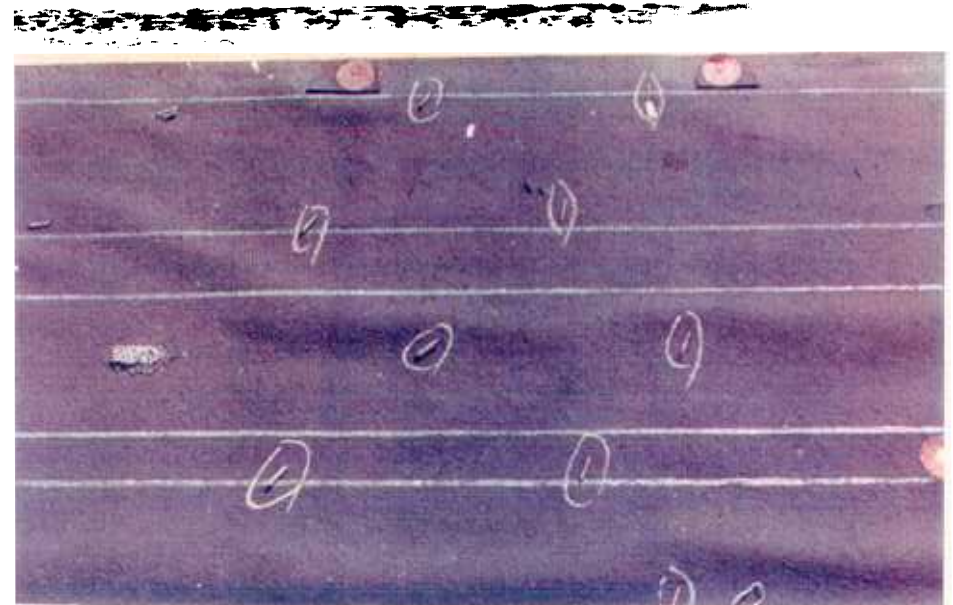
35. Close-up roof view showing staples secured in plywood deck. Many staples are crooked and oriented incorrectly.

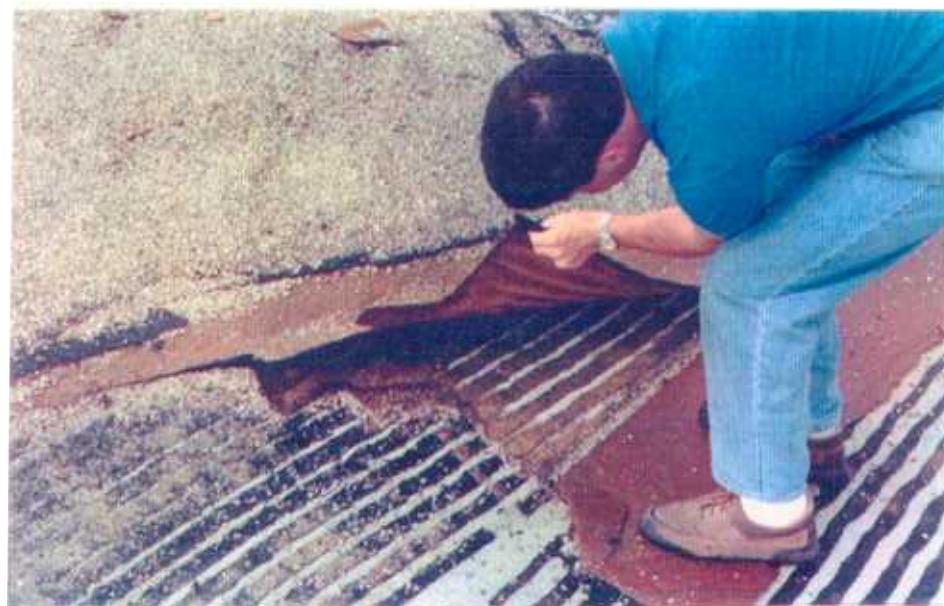
37. Failure of built-up roof covering on warehouse occurred where insulation board was lightly adhered to roof deck.

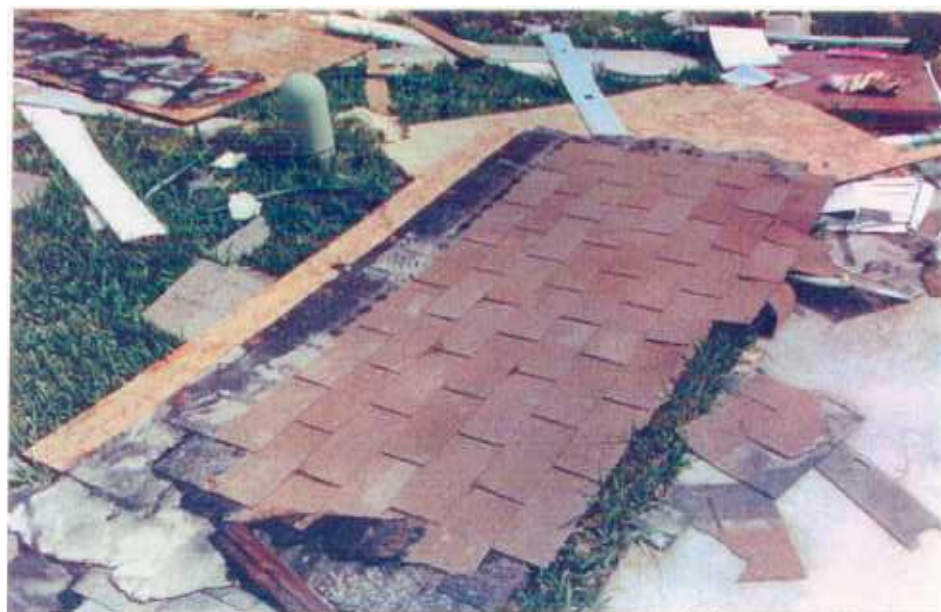
39. Missing full and half sheets of plywood decking on residence (Country Walk).

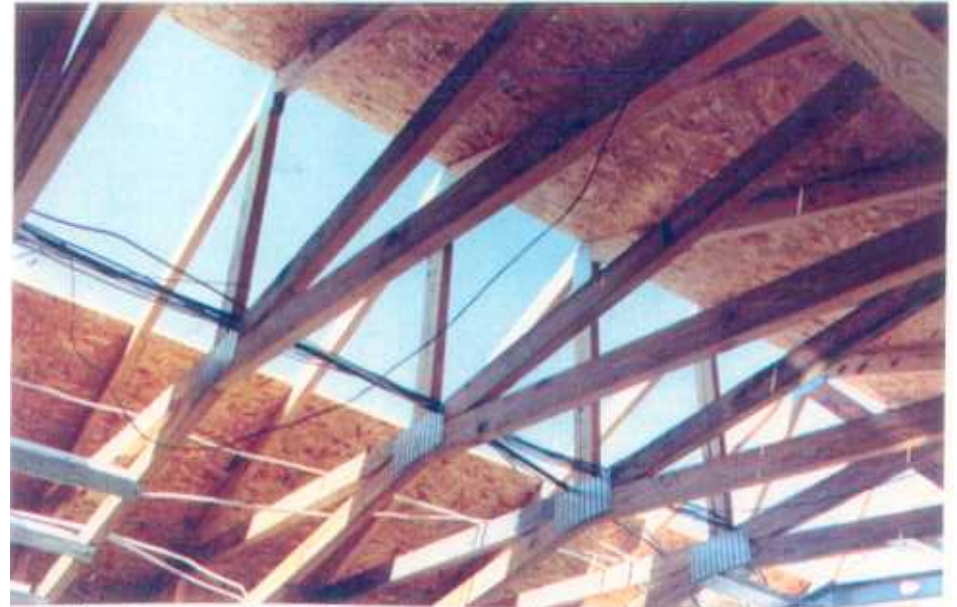
41. Pre-manufactured trusses fell like a stack of dominoes as they were laterally braced only by roof decking.

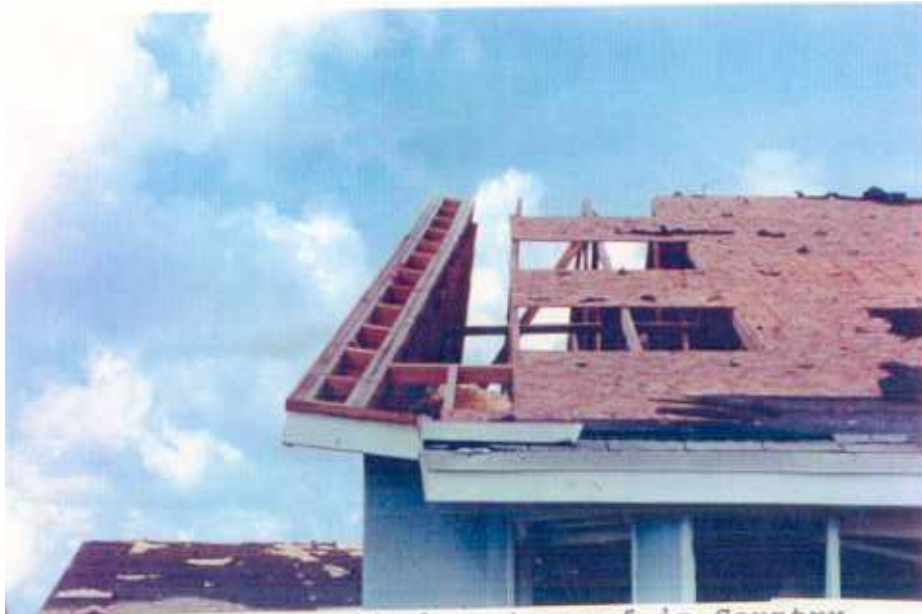
42. Lack of blocking between rafters in Homestead residence.

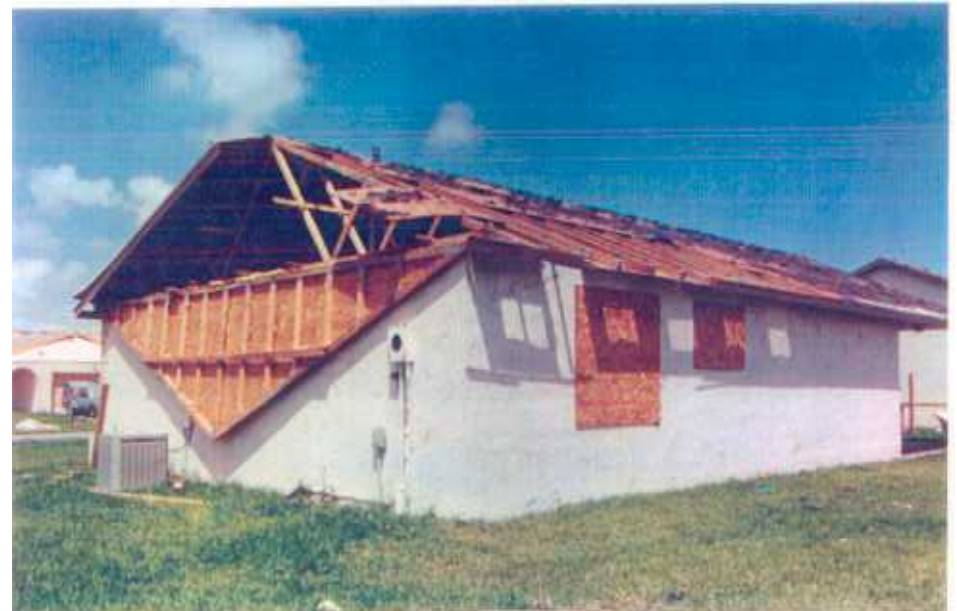
43. Gable end scabbed on to roof in Country Walk subdivision.

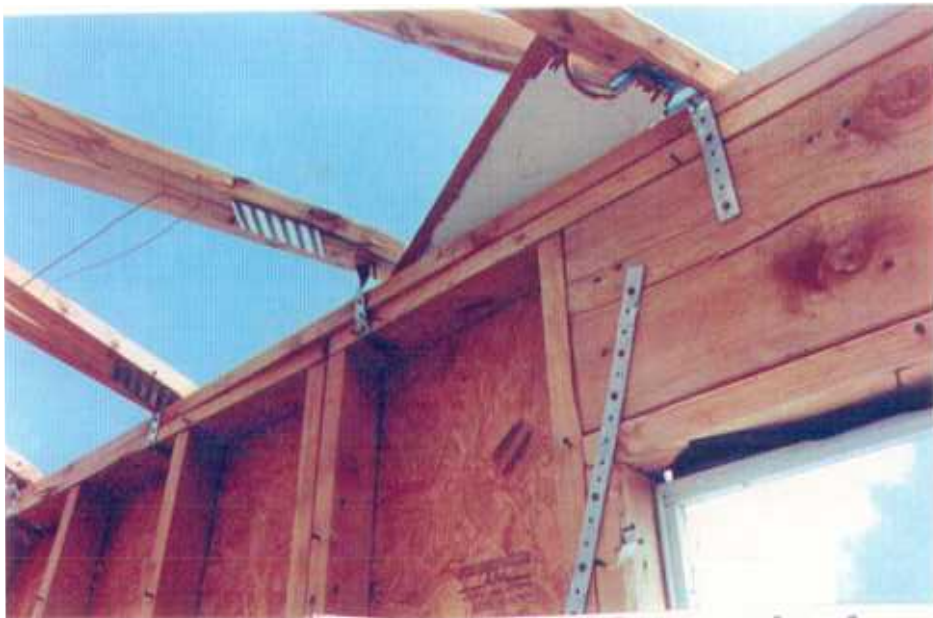
44. Gable end failures were common in several subdivisions in Homestead.

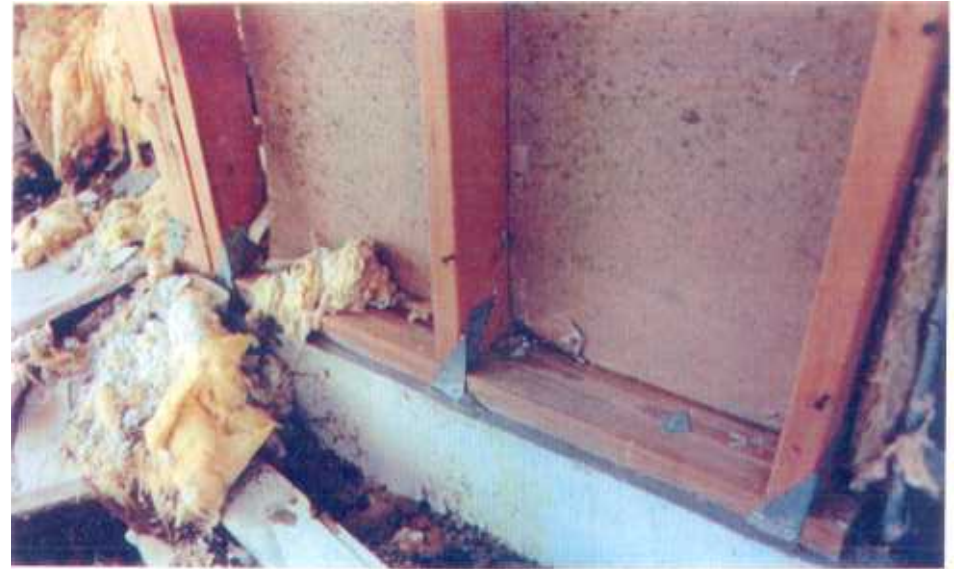
45. Rotation of metal straps along ends of roof trusses in residence.

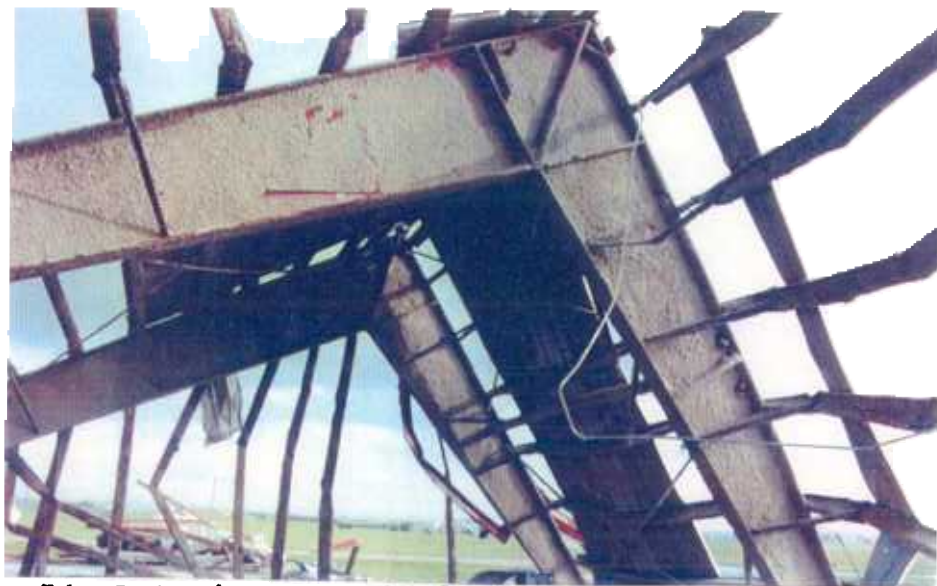
53. Hangar door and end wall failure in metal building at Tamiami Airport. Door faced east.

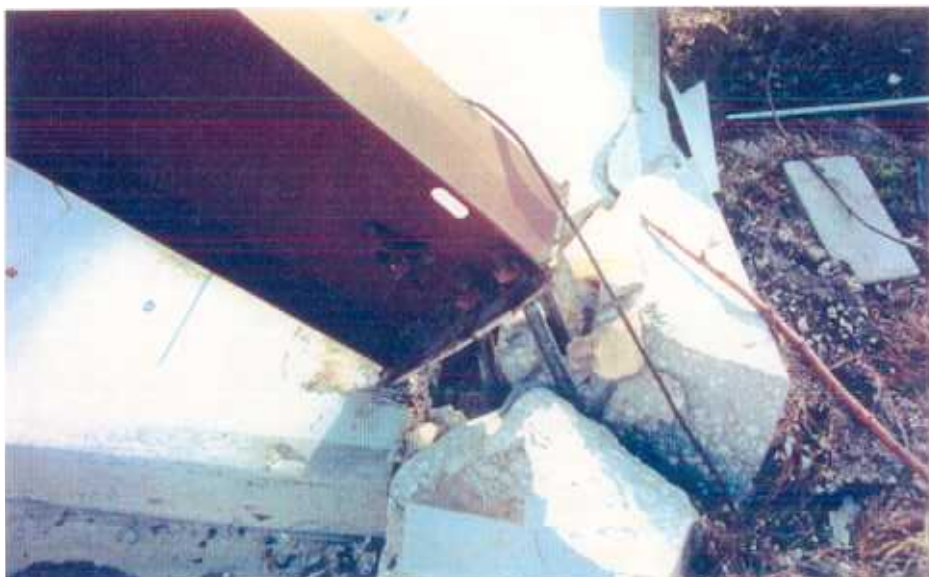
54. Rotation of steel frame occurred when center of hanger collapsed. View looking north at Tamiami Airport.

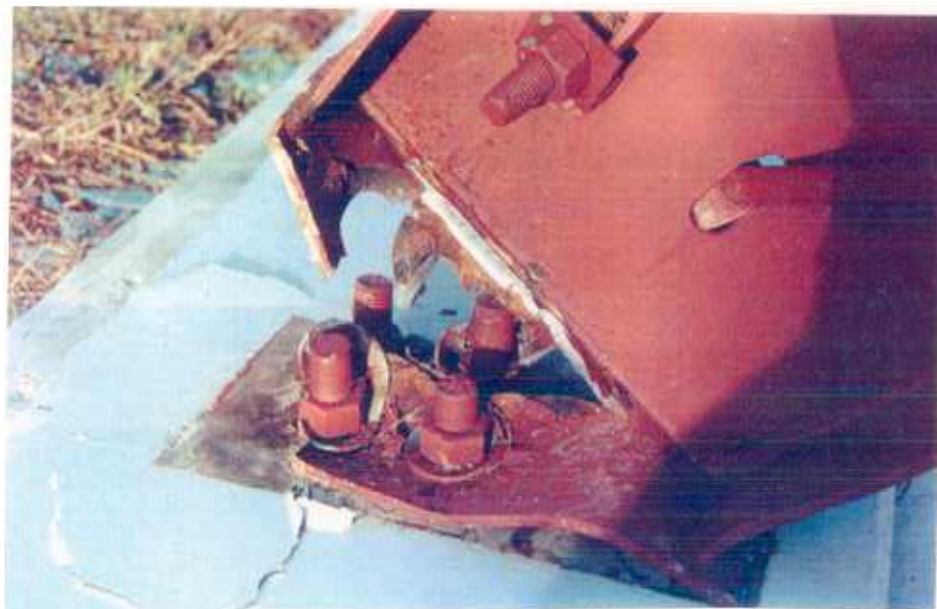
55. Rotation of column base caused steel bolts to pull loose from concrete footing. Note the base plate remained intact.

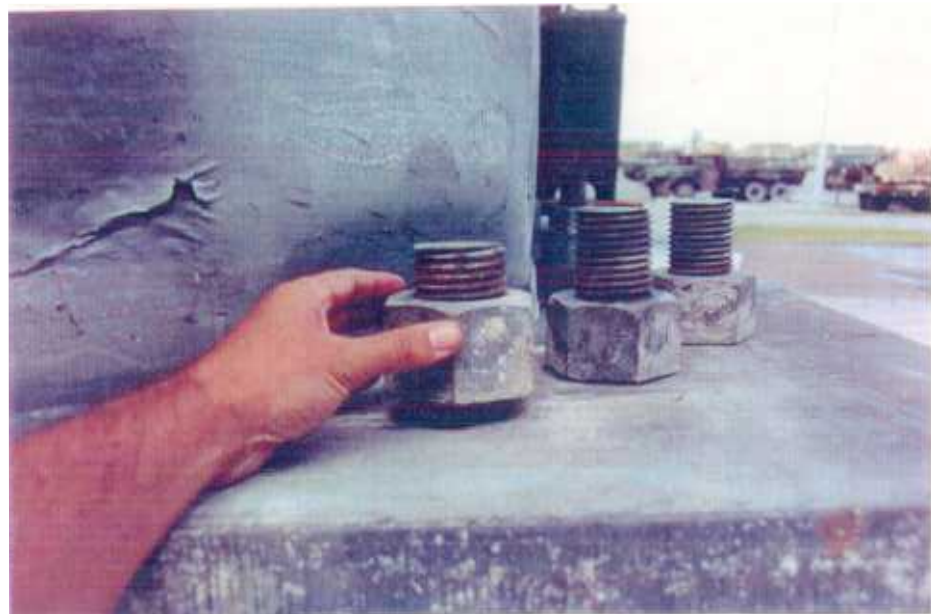
58. Two of six light standards had buckled slightly at base (Homestead).

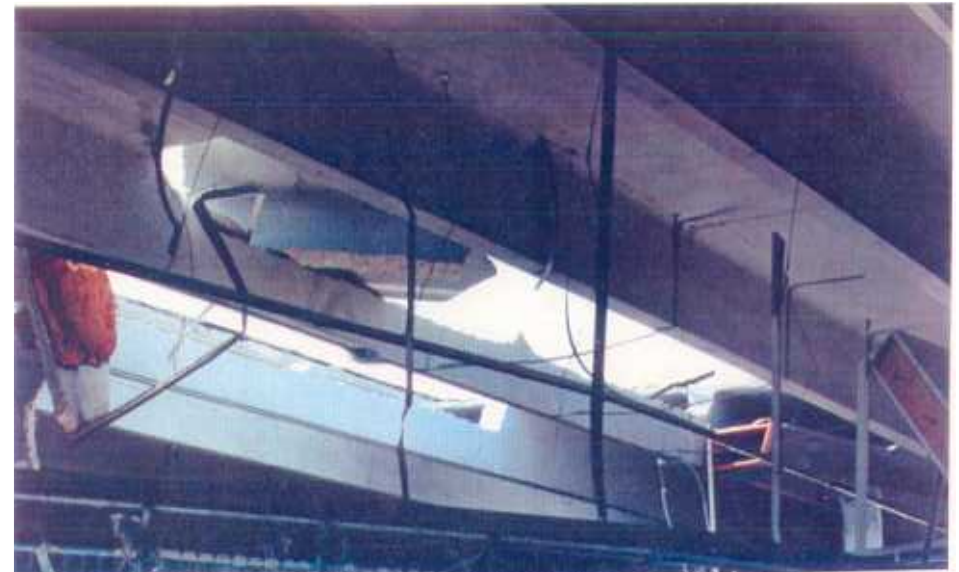
65. Double-tee concrete roof beam failed at center of 55 ft span and fell on top of car which owner hid from storm.

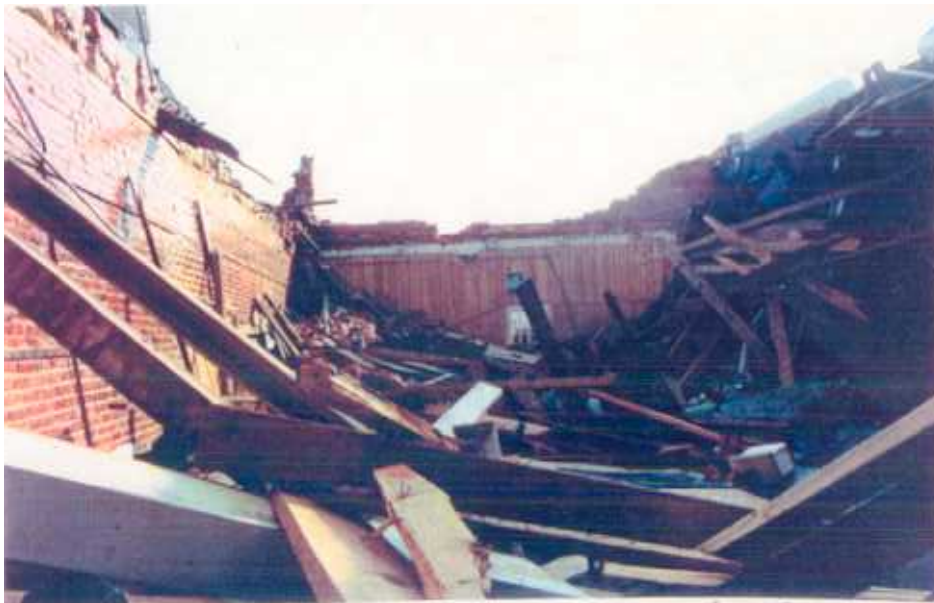
78. Collapse of old wood timber roof on main street in Jeanerette, LA.
