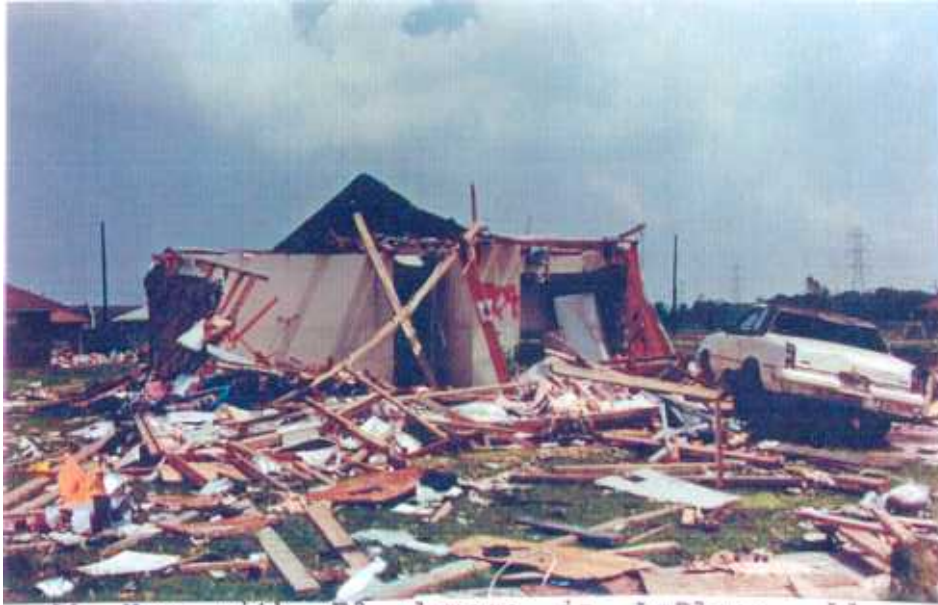
80. LaPlace, LA tornado path was two houses wide. Homes already had been demolished.

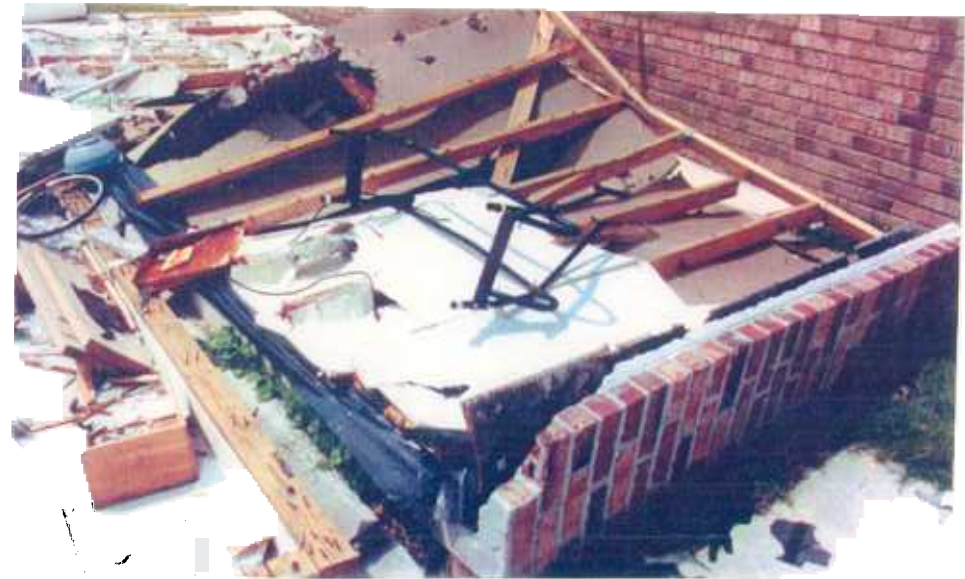
81. Home with F3 damage in LaPlace, LA tornado.

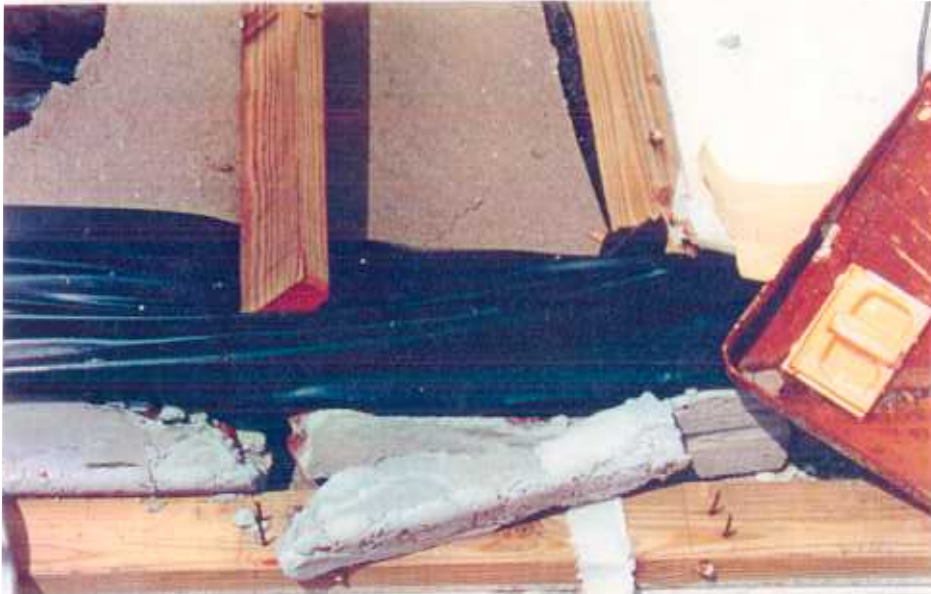
82. Exterior brick wall and framing rotated northward. Failure occurred where wall studs were nailed to anchored bottom plate.

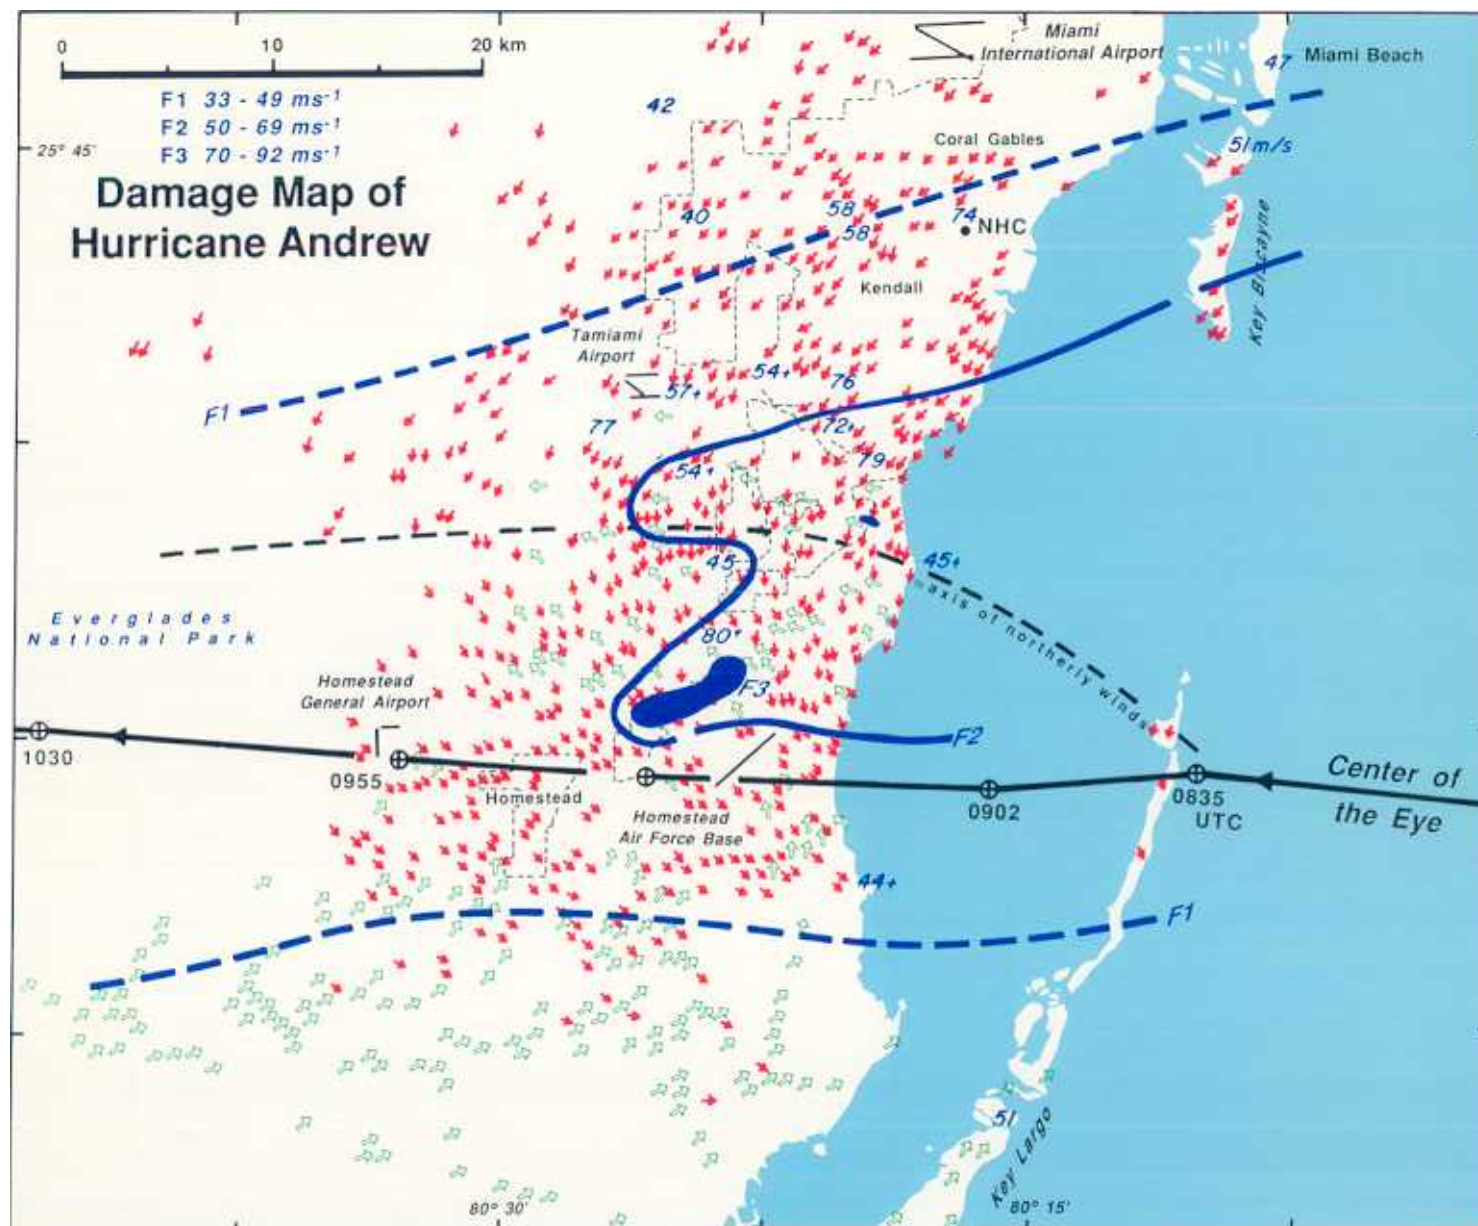
**Damage Map of Hurricane Andrew.** The map, with scale in upper left (1 km equals 0.62 statute miles or 0.54 nautical miles), indicates the direction of peak damaging wind from direction of tree fall and orientation of debris from damaged buildings. The red arrows indicate the direction of the "first wind", the peak damaging wind at the leading, or front, edge of the "eyewall", which is the ring of intense rainfall and highest wind surrounding the clear "eye". The open green arrows indicate the direction of the "second wind", the peak damaging wind at the trailing, or rear, edge of the eyewall. The thick, black line is the track of the geometric center of the eye as seen on Miami and Key West WSR-57 National Weather Service radars. Dots with crosses indicate center positions at approximate half-hourly intervals for indicated times in universal time, UTC (subtract 4 hours for Eastern Daylight Time). The heavy dashed line shows the axis of northerly flow and that it recedes further from the storm track when the center crosses the coast. This is probably due to the increased friction over land relative to over-water causing the wind to angle more strongly inward toward lowest pressure. Numerical values labelled throughout the map are wind speed

estimates from surface anemometers, of variable quality and exposure, in  $\text{ms}^{-1}$  (1  $\text{ms}^{-1}$  equals 2.24 mph). Letters labelled throughout the map indicate key damage survey sites described in Wakimoto and Black ("Damage Survey of Hurricane Andrew and its Relationship to the Eyewall", Bull. Amer. Meteorol. Soc., Feb, 1994).

The f-scale contours are indicated by the blue lines. The lower-case f-scale, as described in Fujita (Mystery of Severe Storms, 1992, p31, NTIS PB92-182021) refers to the degree of damage to any structure types (in this case, CBS), i.e. f0- little damage, f1- minor damage, f2- considerable damage, f3- walls collapse, f4-structure blown down, etc. The dashed line indicates f1, the solid line indicates f2 and the solid shading indicates the f3 region. These contours correspond to the degree of damage to the majority of CBS buildings in the area. The upper-case F-scale, as developed by Fujita ("Proposed Characterization of Tornadoes and Hurricanes by Area and Intensity", U. of Chicago, SMRP Paper 91, 1971) is a scale of 12 wind speed categories ranging from gale force winds (F0=40 mph, Beaufort 8) to the speed of sound (F12=738 mph, Mach 1). The scale, with wind equivalents, is shown on the map and was developed for wood-frame houses, where the f-scale and F-scale numbers are equal. For other types of construction, the f-scale and F-scale must be properly matched. The table to the right is such a matching for CBS construction typical of South Dade County, Florida. The northernmost lobe of the f2 contour (gusts of 176 mph), located between 184th and 152nd Streets, is probably associated with the first wind (from the northeast and east) and the southernmost lobe, over Naranja Lakes and surroundings, including the f3 contour (gusts of 202 mph), is probably associated with the second wind (from the southeast). (Copies available from NOAA/NWS, Forecast and Warnings Branch, 1325 East-West Hwy, Silver Spring, MD 20910) Map produced for the NOAA-Hurricane Research Division (HRD) by Roger Wakimoto (UCLA), caption by P. Black (HRD), based on joint flights by R. Wakimoto and N. Atkins (UCLA) and G. Forbes (Penn State). Survey and printing cost supported by Office of the Federal Coordinator for Meteorology, NOAA/Office of Oceanic and Atmospheric Research and NOAA/National Weather Service.
