19890918I1-RADAR

### E.5 Doppler Radar Scientist (On-Board)

Doppler Radar Scientist Check List

Flight ID 890918Z  
Aircraft # 43RF  
Operators MARKS  
Radar Tech. ROLLS/GOLDSTEIN

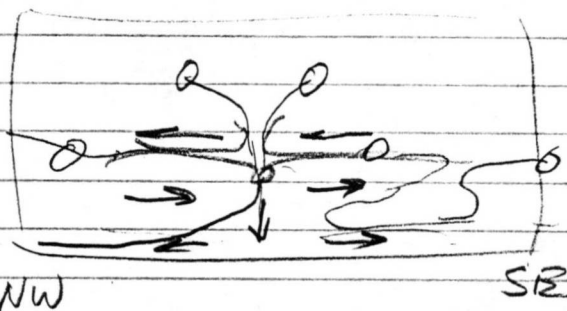
Same weird Doppler as yesterday.

0 isodap does not intersect  
ground below plane  
elevation looks fine.

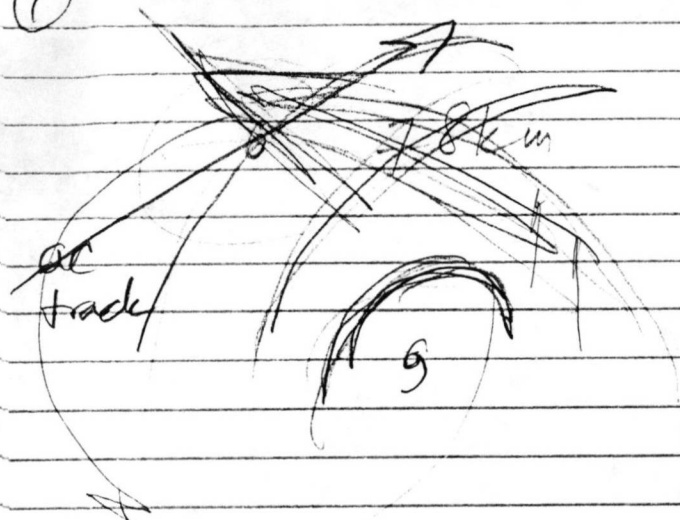
2017 deep inflow from right side  
now strange pattern & pretty  
much gone now.
