NOAA Ship Ronald H. Brown A16N Leg 2 Scientific Report 04
John Bullister, Chief Scientist, Rolf Sonnerup, Co-Chief Scientist

Sunday, September 15, 2013

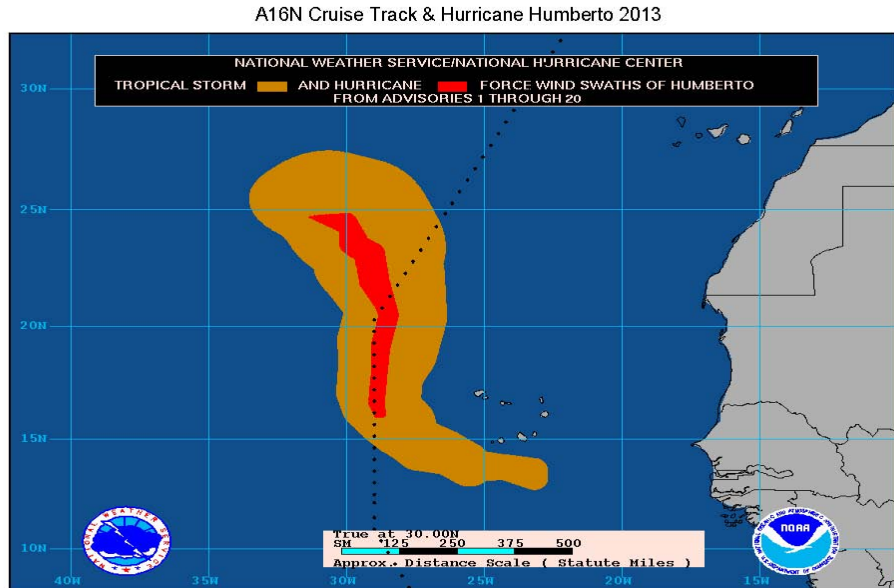
The tropical depression that we had been monitoring during the previous week continued to develop and became Tropical Storm Humberto earlier this week. By mid-week its intensity increased and it became Hurricane Humberto (the first hurricane to develop in a remarkably quiet season so far). The path of Humberto was projected to almost perversely follow along our station line at 29°W from 20°N to 15°N (see black dots on attached figure by Katie Kirk), a remarkably bad coincidence.

To avoid the path of the oncoming storm, at about 20.5°N RHB diverted eastward about 200 miles from the line. We then steamed southward about 180 miles to a point near the Cape Verde Islands, and as Humberto continued to move northward, RHB steamed back to the line at about 17.5°S and occupied stations northward behind the storm, where conditions allowed us to work safely.

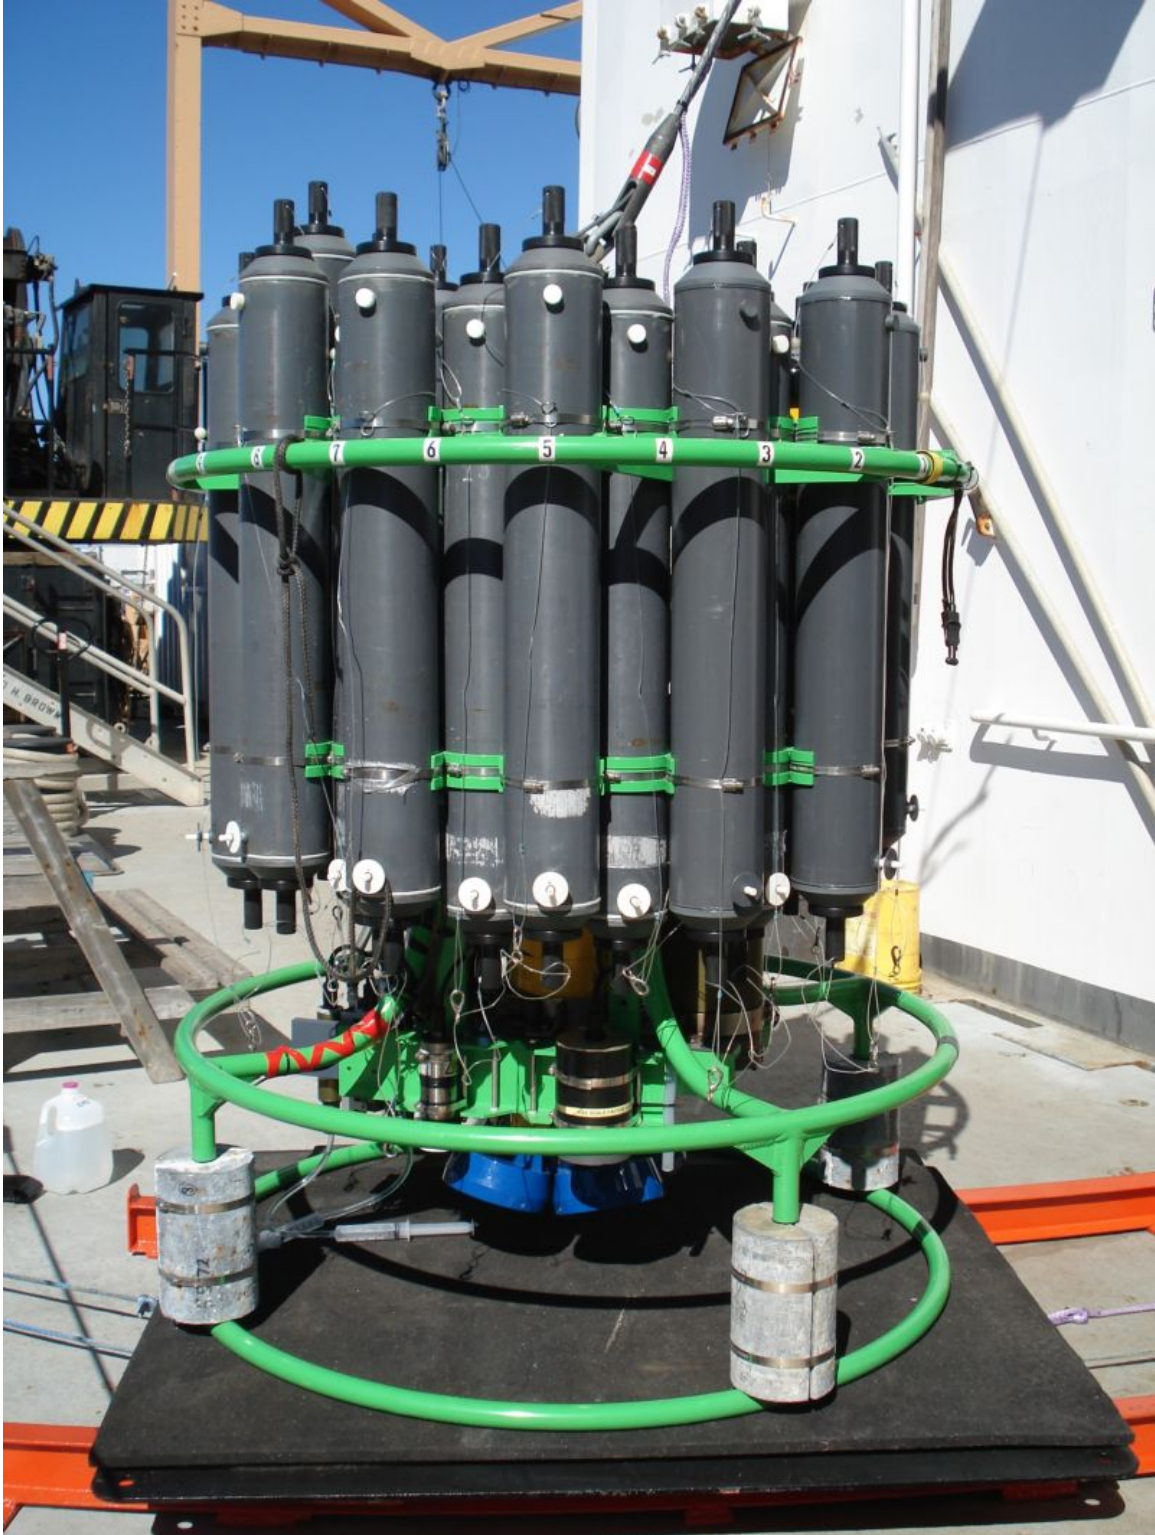
At about 19:24 GMT on 14 September 2013 at Sta 96 (17°N 29°W), with about 2872 meters of CTD cable out, the cable parted and the rosette package (see attached photo) was lost. Before Station 96, we had been having winding problems with the aft winch for the past dozen or so stations and decided to switch the rosette package to the forward winch. Unfortunately, although the CTD cable appeared in excellent conditions on the outer layers of the drum of this winch, the inner layers of the cable were extremely corroded. Based on the condition of the remaining cable on the aft winch, this winch will be unusable for the remainder of the cruise.

We quickly outfitted the backup rosette during the next several hours and attached this package to the aft winch. We have been able to complete several stations since then and will continue on with our plans to complete the section.

We will continuously and closely monitor the winding on this winch for the remainder of the cruise.
