**ENVIRONMENTAL ASSESSMENT REPORT  
FOR  
COLUMBUS LANDING: A MARINA, RESTAURANT, SHOPPING AND OFFICE COMPLEX,  
AT  
ESTATE MORNINGSTAR  
ON  
SUGAR BAY (SALT RIVER)  
ST. CROIX, U.S. VIRGIN ISLANDS**

Submitted To:  
Division of Coastal Zone Management  
Department of Conservation and Cultural Affairs  
Virgin Islands Government

Submitted by:  
Haines Enterprises, Inc.  
Kingshill, St. Croix, VI

Prepared by:  
Coastal Consultants  
Kingshill, St. Croix, VI

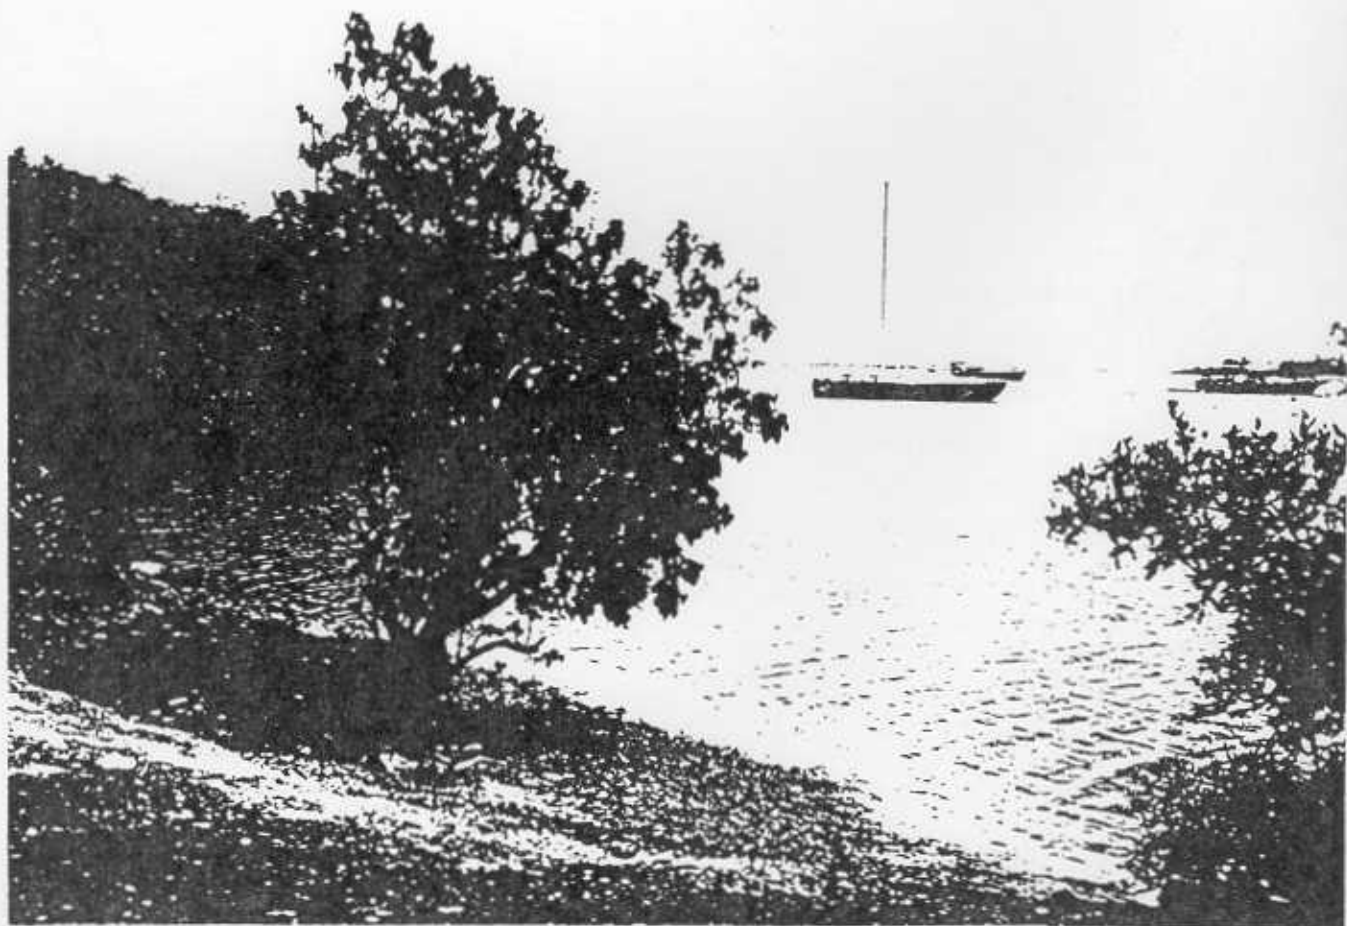
Photo No. 4. View of dirt boat ramp, looking toward the northeast. Salt River Bay is behind boats. Photo taken April, 1986.

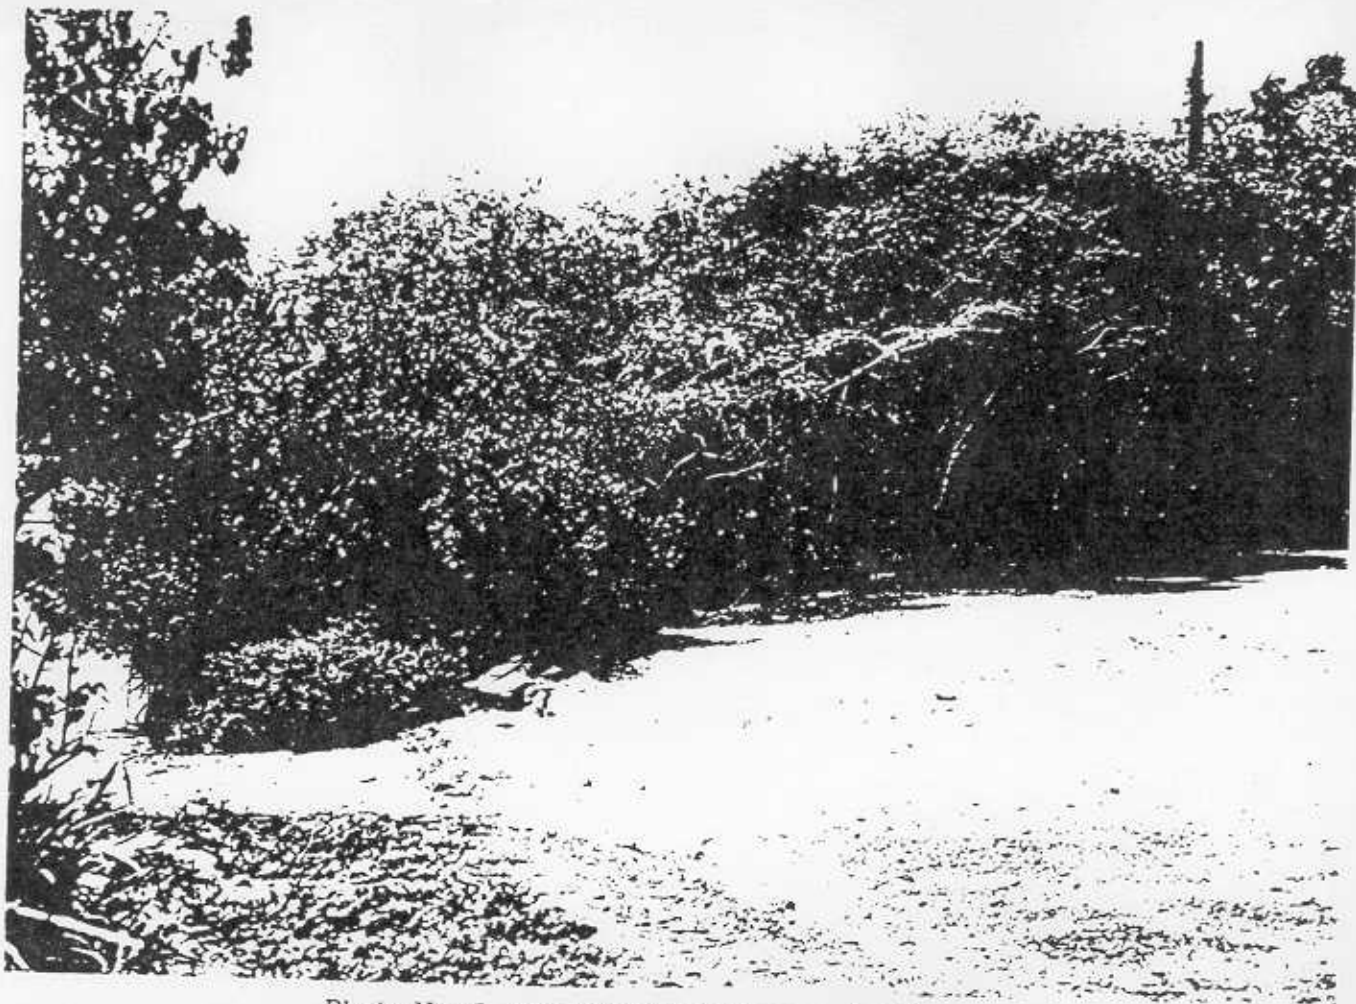
Photo No. 5. View of dirt boat ramp, looking toward southeast. North Shore Road on right side, Sugar Bay on left. Photo taken April, 1986.

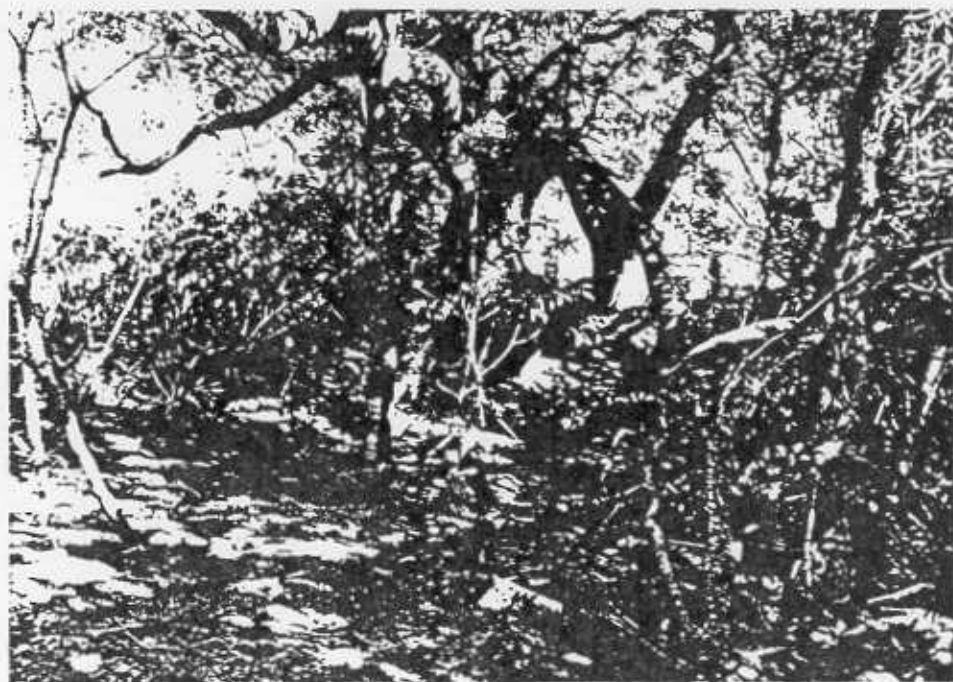
Photo No. 8. View south on Plot 30, showing a large black mangrove tree located about three feet from the high tide line. Red mangroves to the left. Photo taken March 23, 1987.
