19770901II-RADAR

Here are the pictures and comments from  
the flight on 43 for Sept. 1, 1977.

770901 I

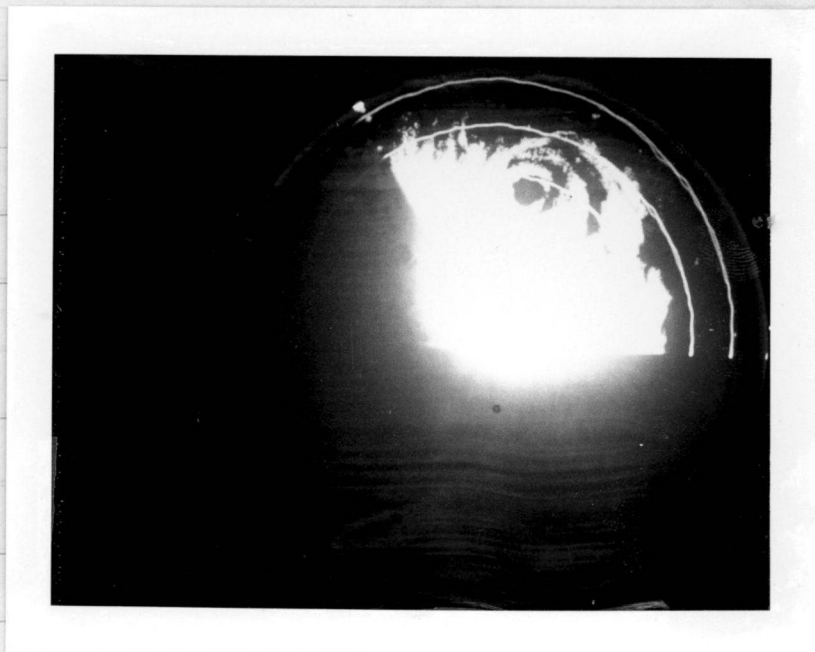
7.

| File. | Time | Alt. | RA | Lat. | Lon. | MO/WS | Scope |
|---|---|---|---|---|---|---|---|
| 7 | 191230 | 253.0 | 318 | 25.01 | 94.69 | 161/26 | PPI |

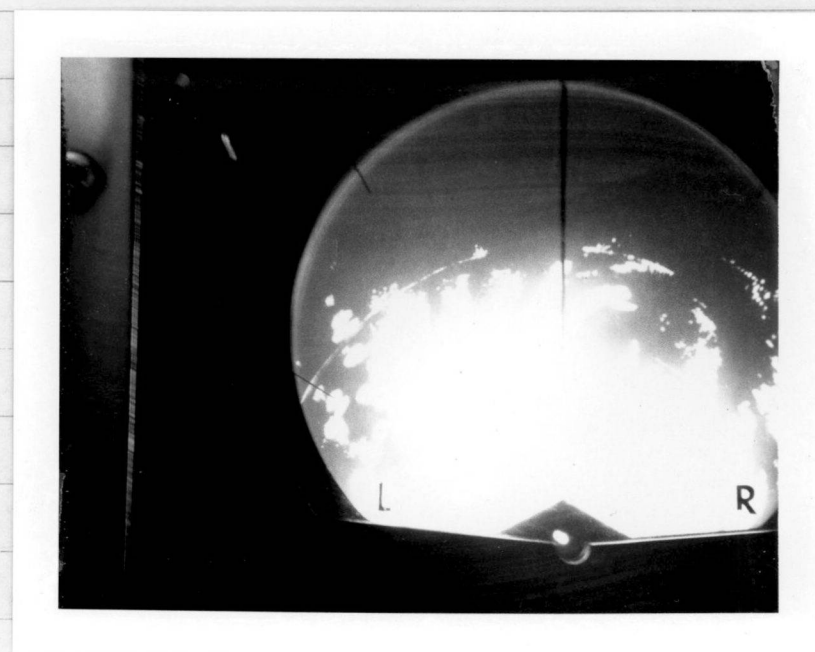
8.

| File. | Time | Alt. | RA | Lat. | Lon. | MO/WS | Scope |
|---|---|---|---|---|---|---|---|
| 8 | 191600 | 251.0 | 332 | 24.99 | 94.94 | 170/25 | Nose |

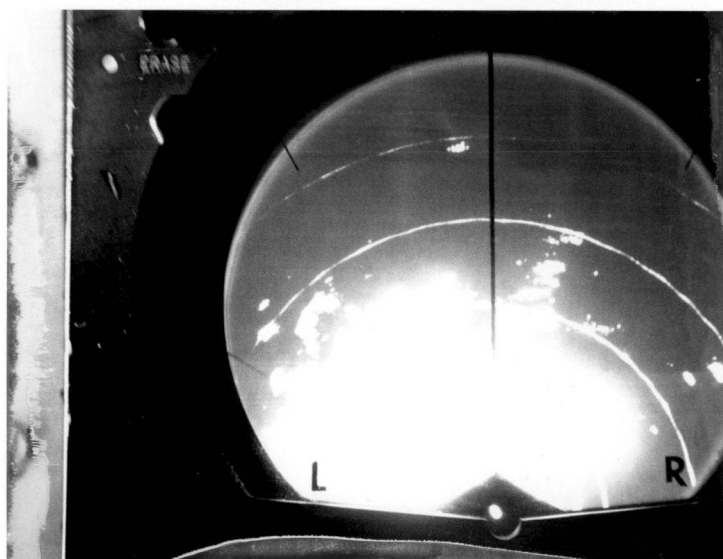
12.

| File. | Time | Alt. | RA | Lat. | Lon. | MO/WS | Scope |
|---|---|---|---|---|---|---|---|
| 12 | 193242 | 78.0 | 355 | 24.91 | 95.67 | 182/03 | Nose |

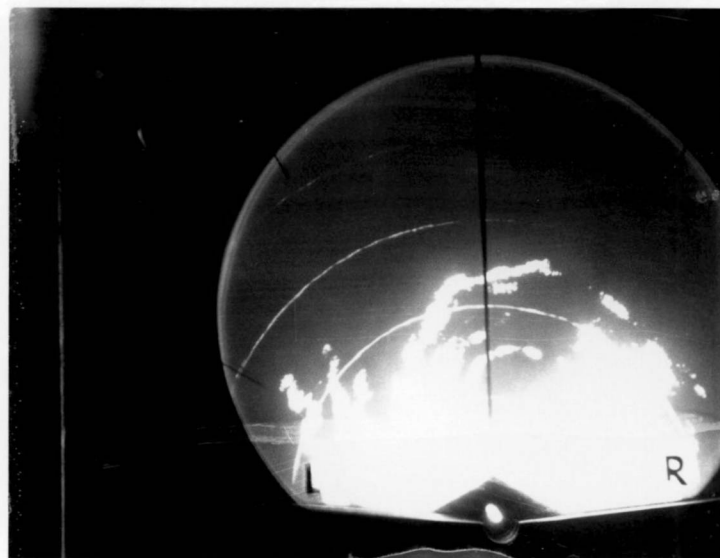
19.

| File. | Time | Alt. | RA | Lat. | Lon. | MO/WS | Scope |
|---|---|---|---|---|---|---|---|
| 19 | 195809 | 345.1 | 353 | 24.55 | 95.69 | 240/49 | Nose |

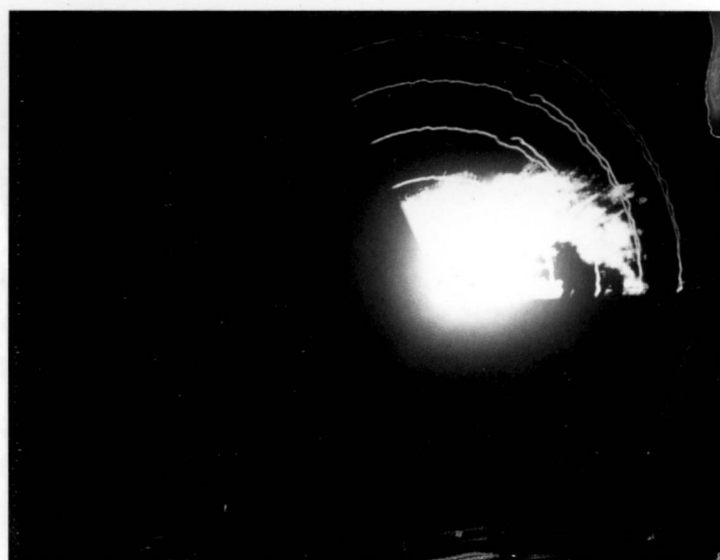
21.

| File. | Time | Alt. | RA | Lat. | Lon. | MO/WS | Scope |
|---|---|---|---|---|---|---|---|
| 21 | 201630 | 20.2 | 391 | 25.51 | 95.75 | 078/42 | PPI |

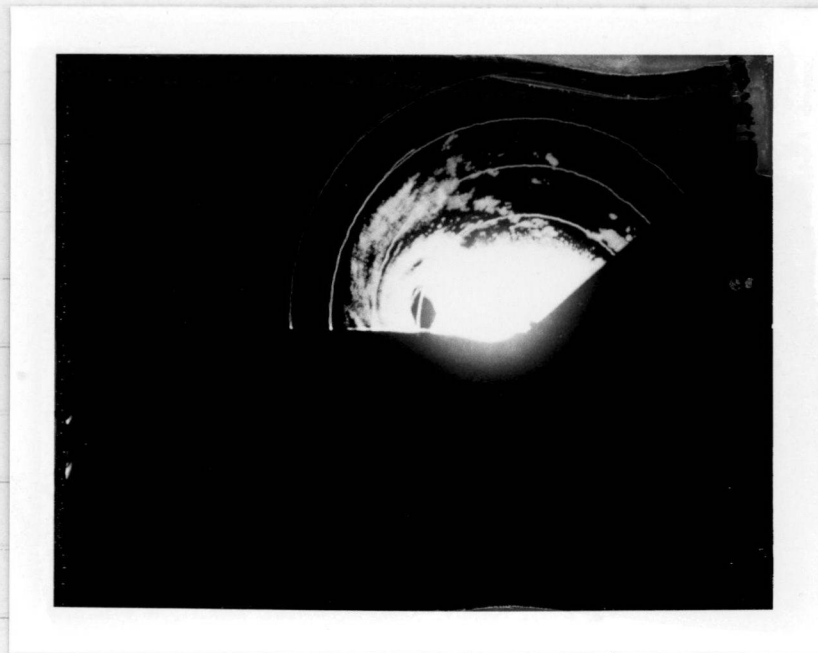
22.

| File. | Time | Alt. | RA | Lat. | Lon. | MO/WS | Scope |
|---|---|---|---|---|---|---|---|
| 22 | 202030 | 243.0 | 346 | 25.55 | 95.99 | 066/41 | PPI |

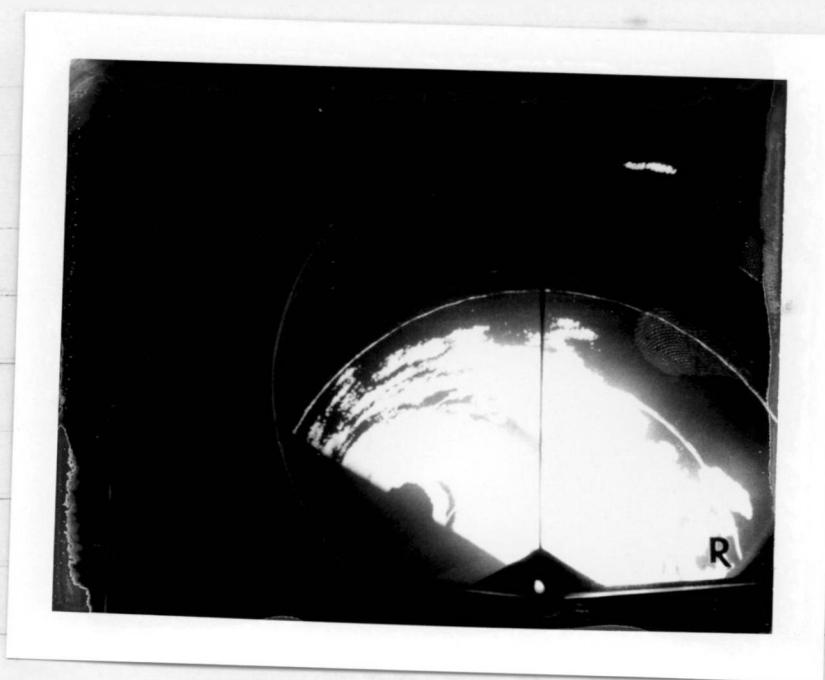
25.

| File. | Time | Alt. | RA | Lat. | Lon. | MO/WS | Scope |
|---|---|---|---|---|---|---|---|
| 25 | 202930 | 161.3 | 302 | 24.96 | 96.35 | 353/42 | Nose |

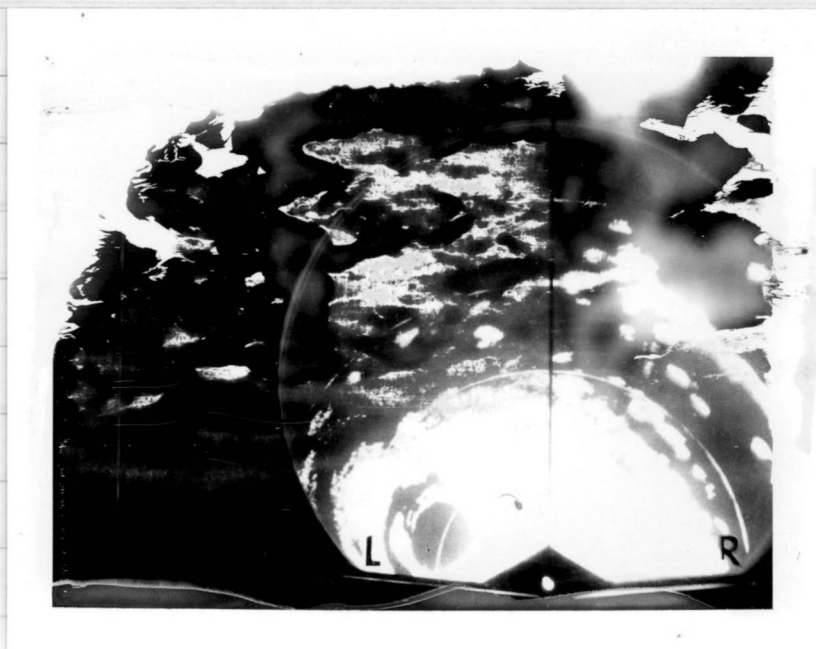
27.

| File. | Time | Alt. | RA | Lat. | Lon. | MO/WS | Scope |
|---|---|---|---|---|---|---|---|
| 27 | 204030 | 90.6 | 299 | 24.49 | 95.76 | 255/44 | Nose |

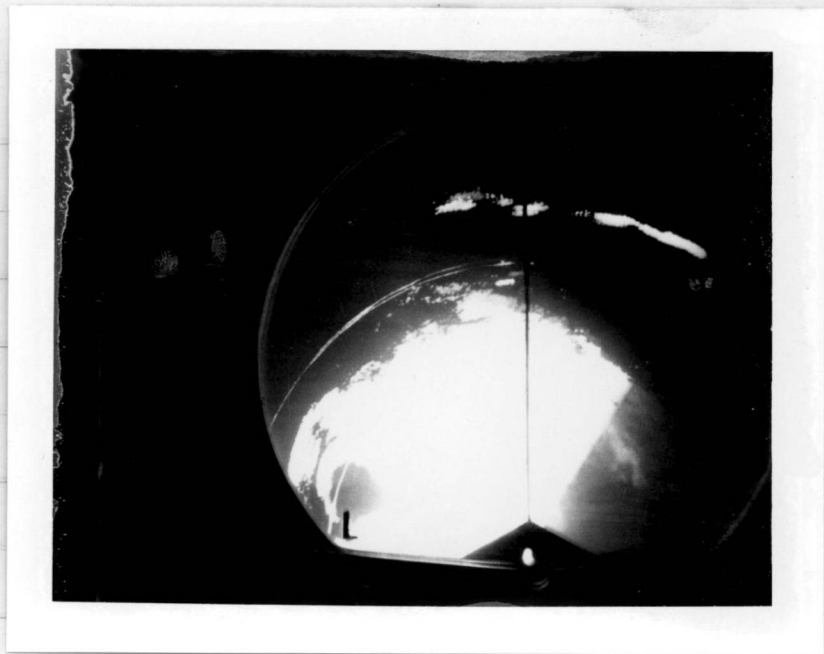
40.

| Pic. | Time | Hdg. | RF | Lat. | Lon. | WD/WS | Scope |
|---|---|---|---|---|---|---|---|
| 40 | 215800 | 104.7 | 334 | 24.29 | 96.34 | 291/35 | Nose |

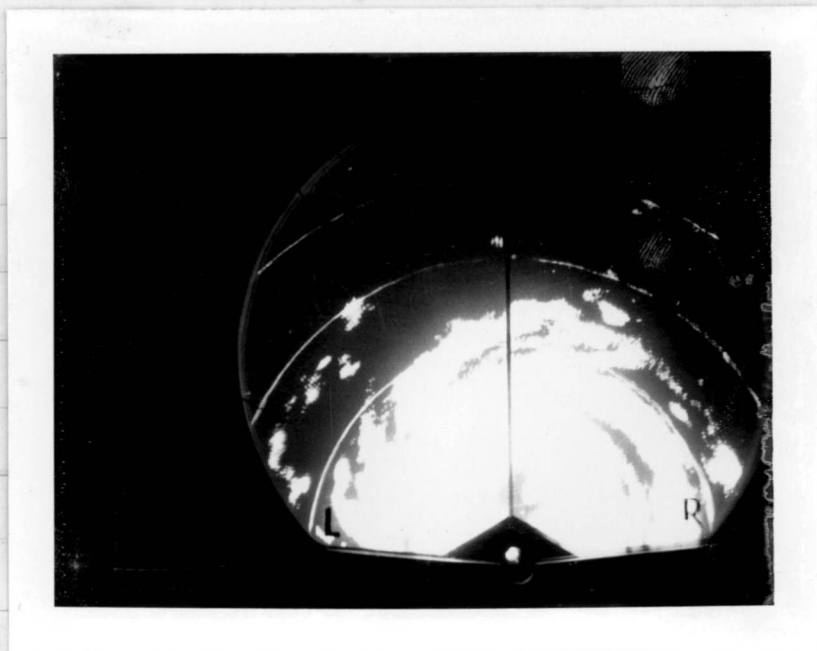
52.

| Pic. | Time | Hdg. | RF | Lat. | Lon. | WD/WS | Scope |
|---|---|---|---|---|---|---|---|
| 52 | 225500 | 78.1 | 331 | 24.75 | 96.23 | 002/58 | Nose |

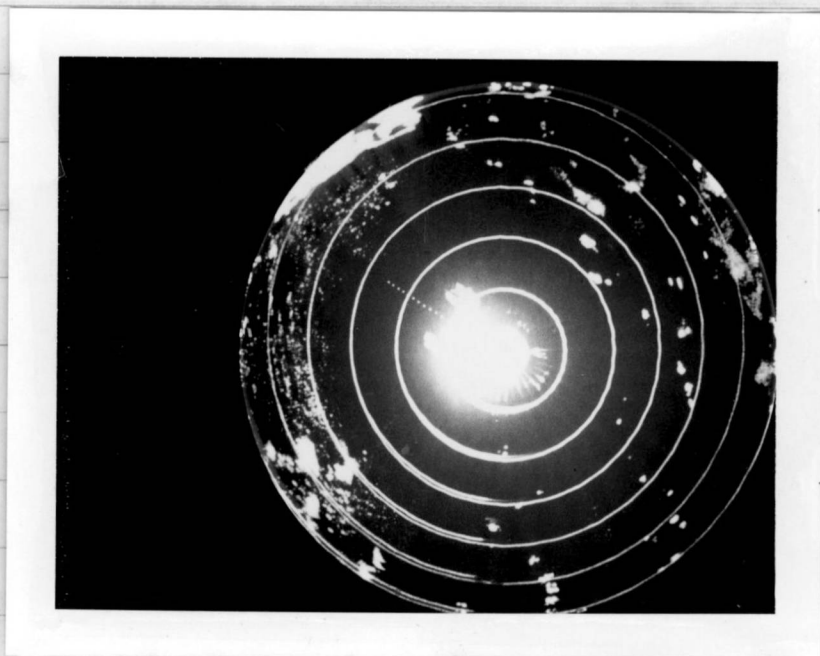
56.

| Pic. | Time | Hdg. | RF | Lat. | Lon. | WD/WS | Scope |
|---|---|---|---|---|---|---|---|
| 56* | 010811 | 89.4 | 1534 | 26.04 | 85.72 | 274/21 | PPI |

\* Tilt was set at  $+2\frac{1}{2}^{\circ}$
