TECHNICAL REPORT

CHURCH GABBRO Technical Note  
Systems Description and Performance

by  
Scott C. Daubin

Prepared for the Office of Naval Research under Contract  
N00014-67-A-0201-0024; NR 292-117/9-25-72(Code 102-OSC).

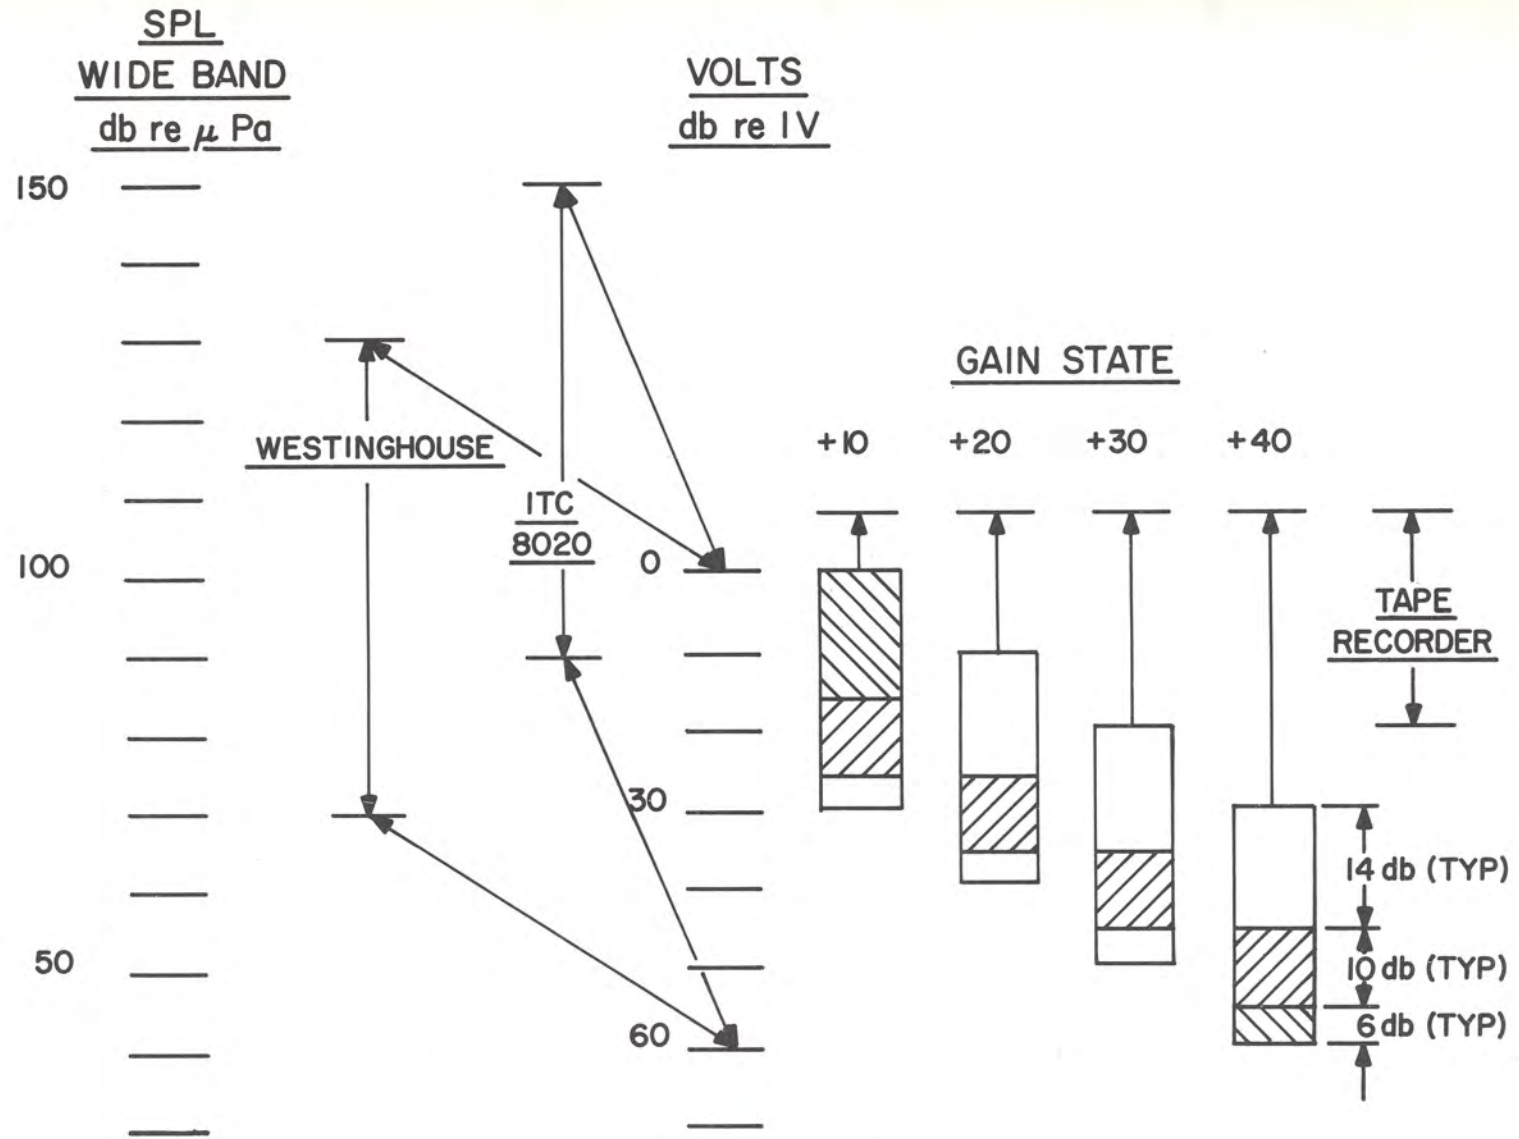
Figure 8

ACODAC Level Ranges

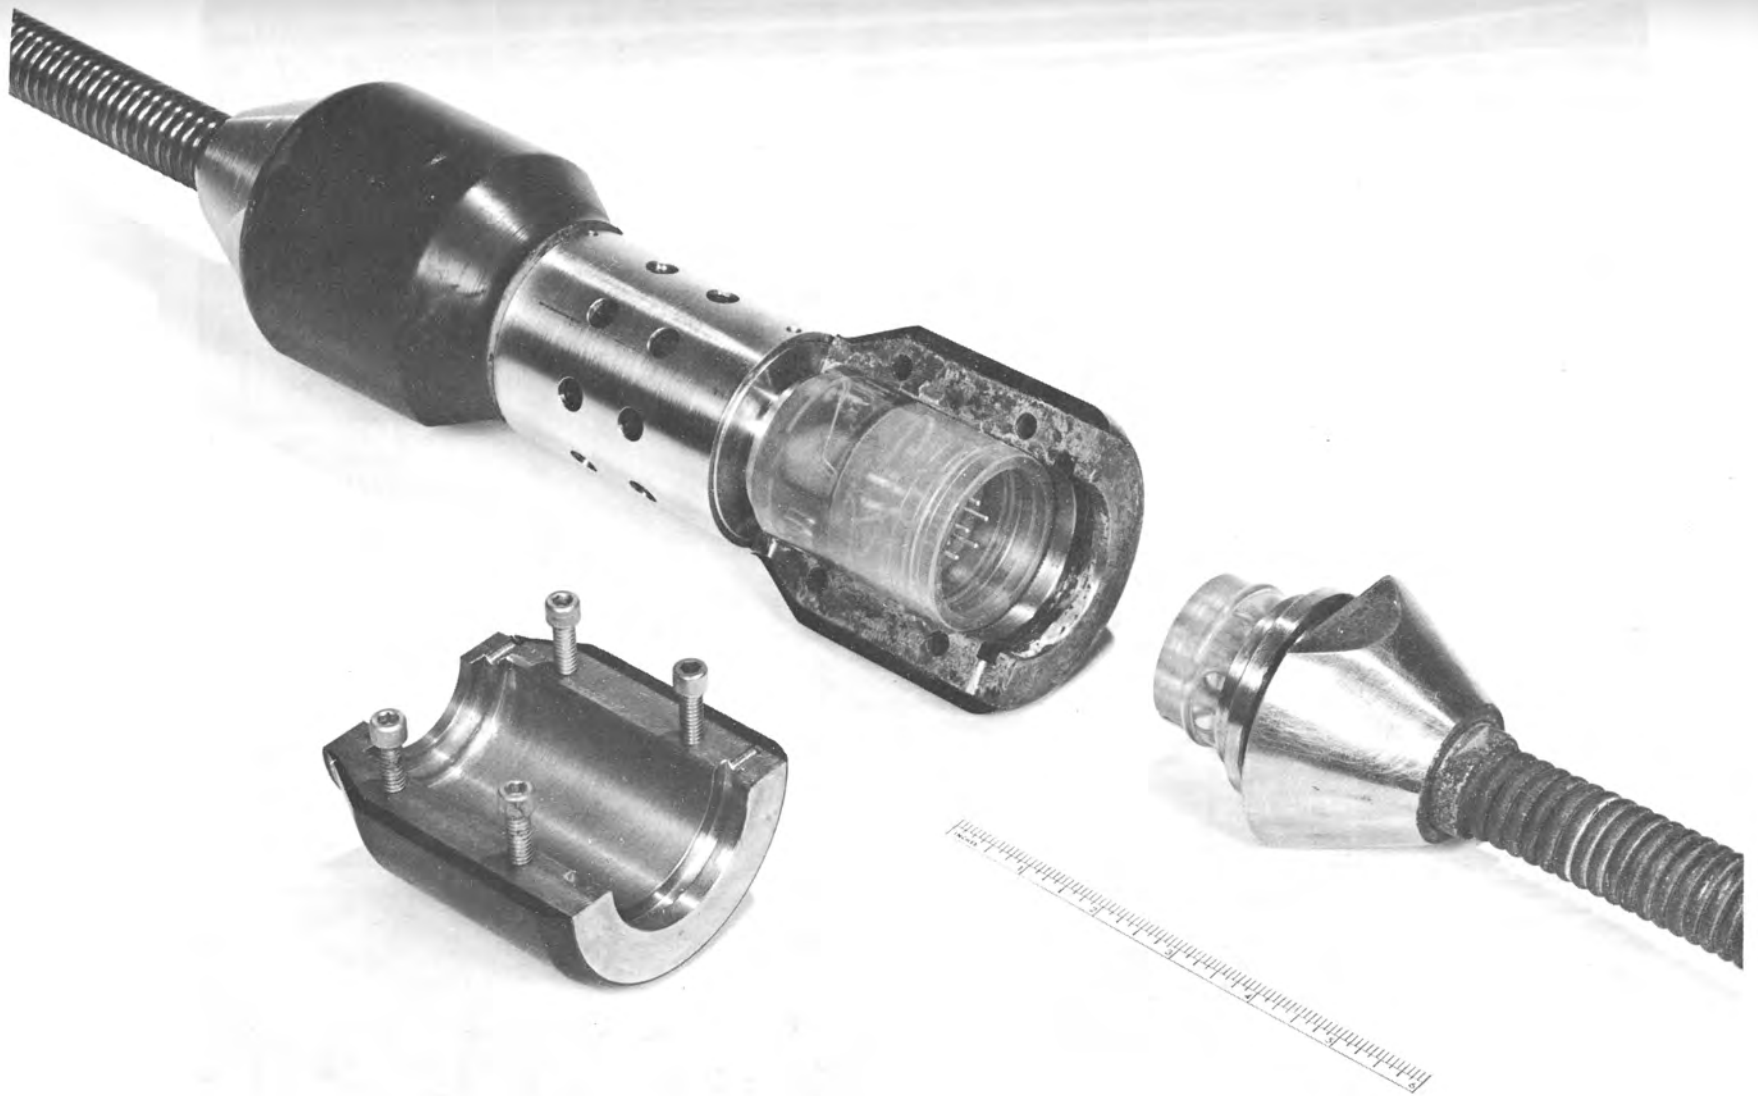
Figure 12

Cable Attachment Scheme  
Westinghouse Hydrophone

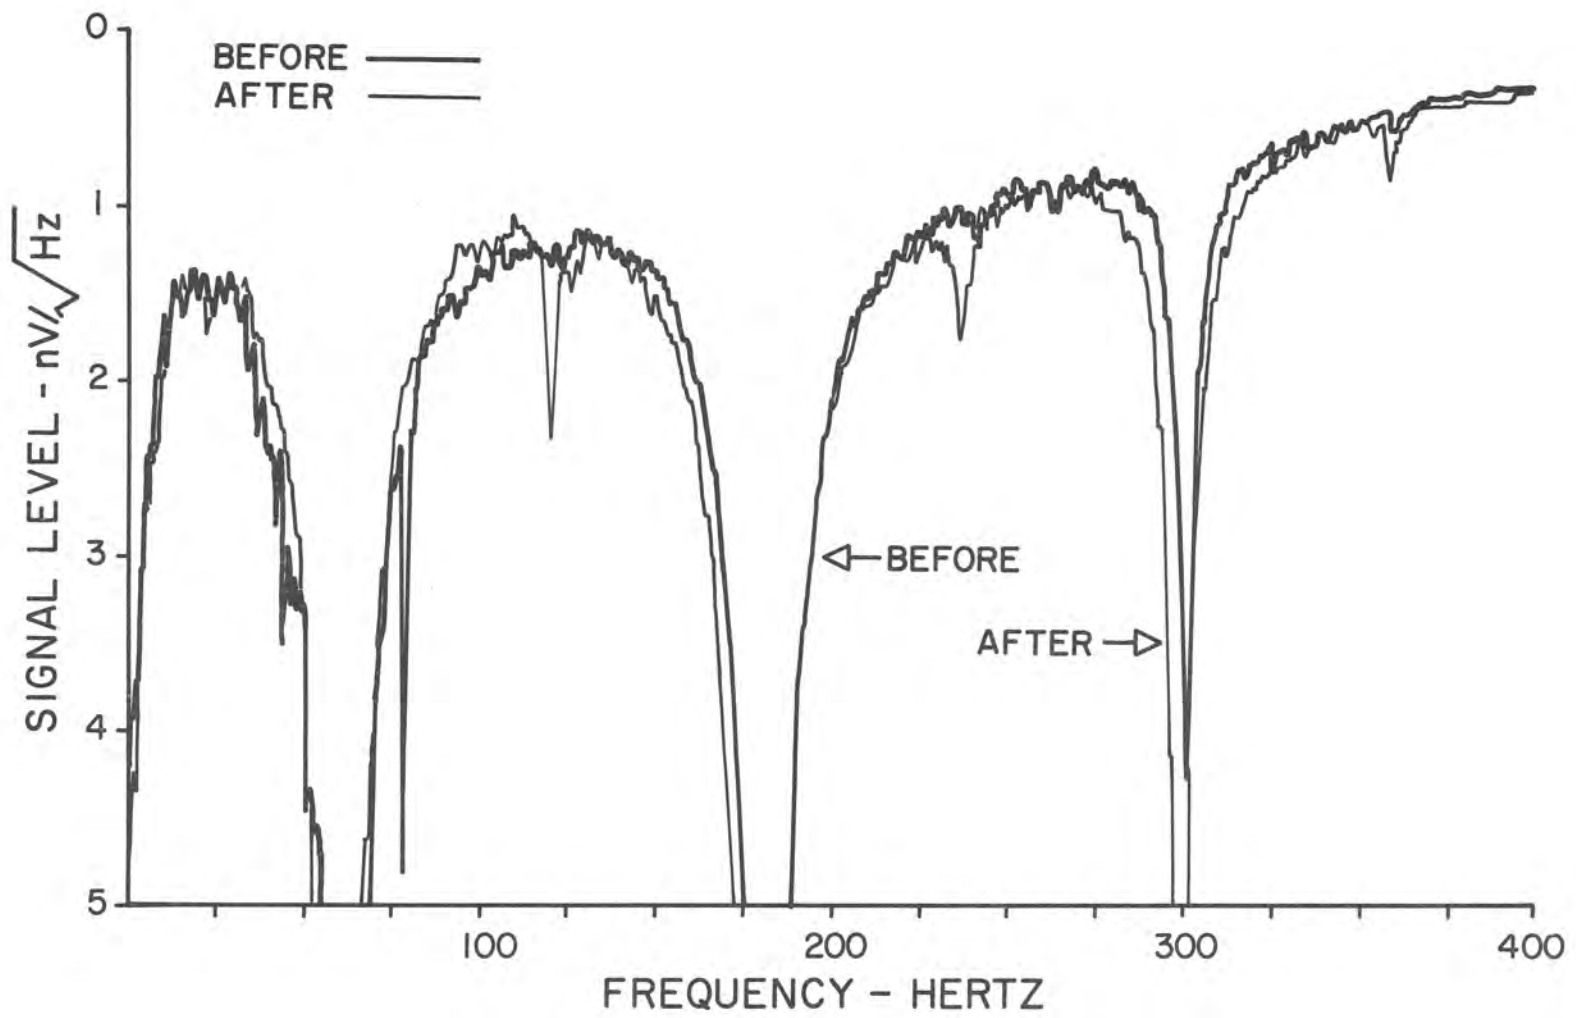
NOISE LEVEL OF FET #5 BEFORE AND AFTER TEMPERATURE AND PRESSURE CYCLING

150°C for 2 hours, cooled and tested. Next, the units were placed in a bag of castor oil and were pressure cycled three times to 10,000 psi. Figure 16 illustrates a noise spectrum before and after the tests. Table III summarizes the results at 100 Hz and 200 Hz for the four units. The largest increase was 30% in voltage. This was deemed satisfactory.

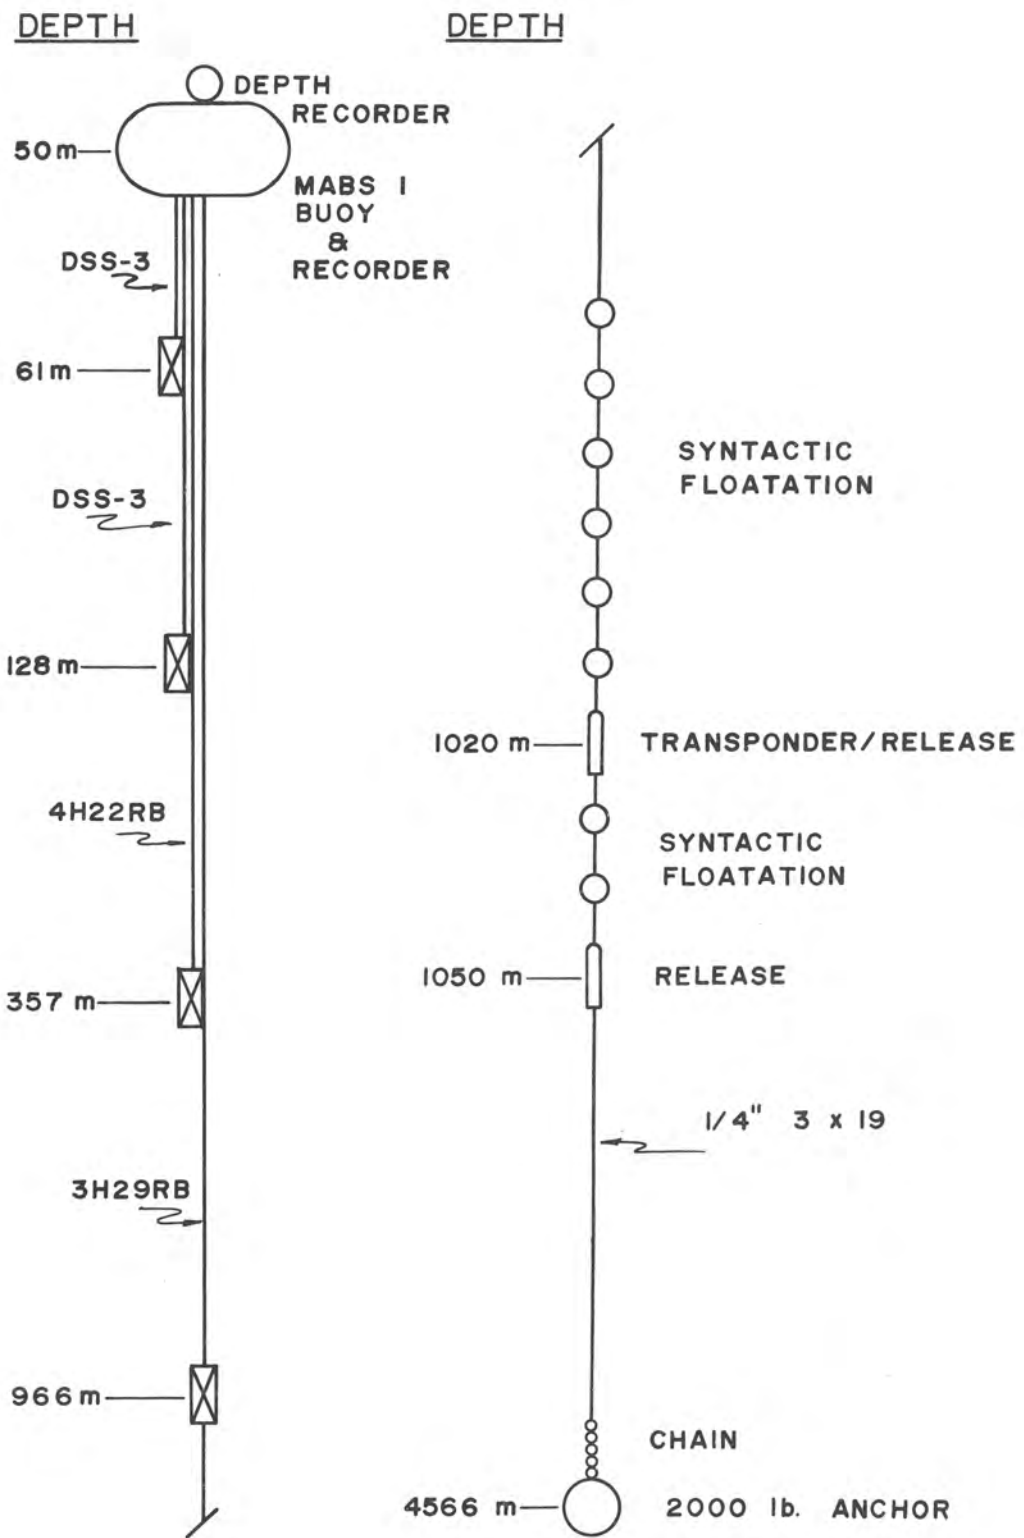
Figure 31

MABS Configuration

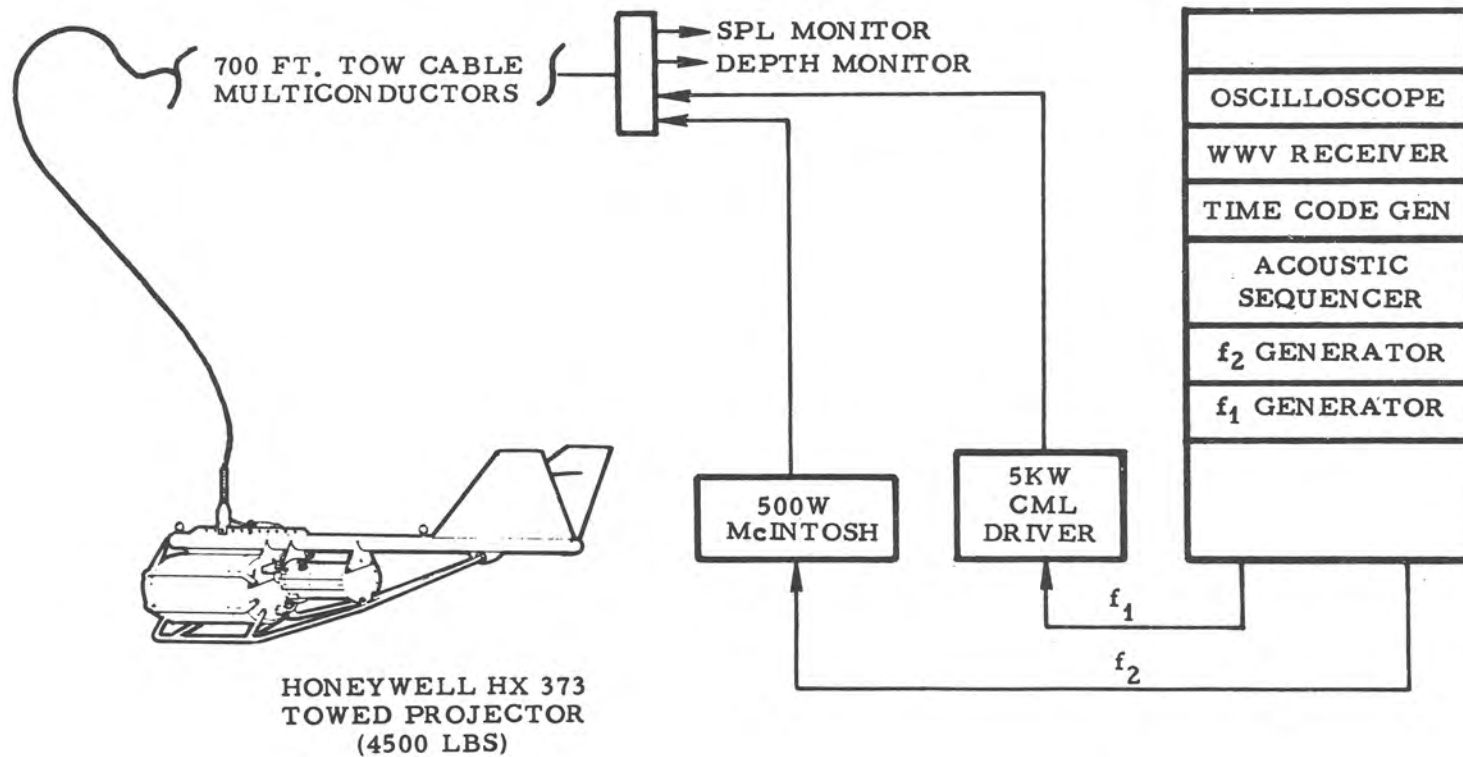
Figure 42

Remote Acoustic Projector System  
[From Reference (1)]

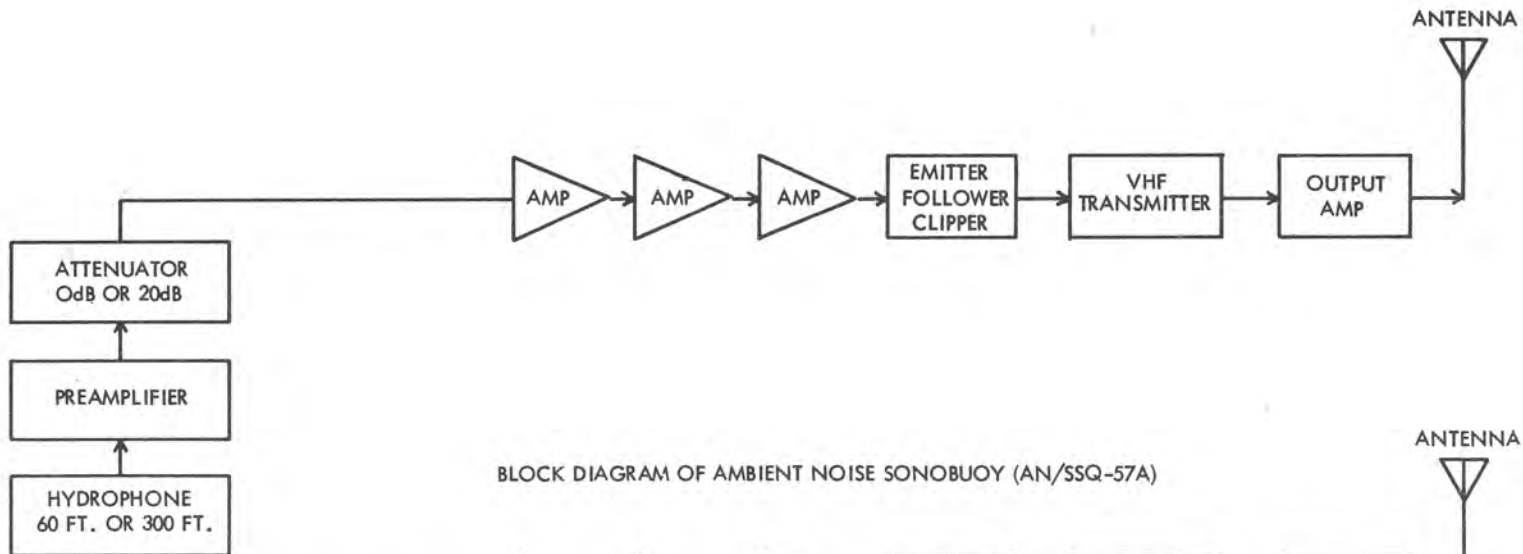
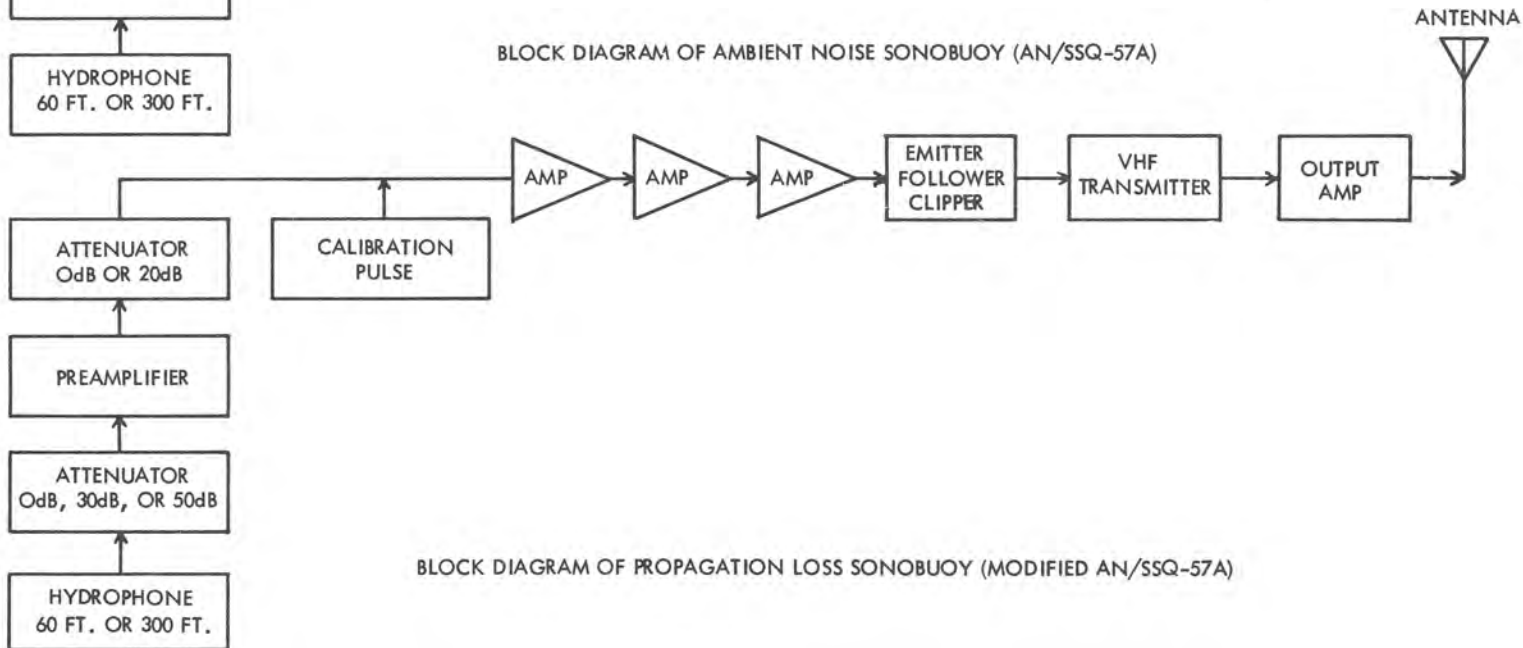
Figure 44

Sonobuoy (AN/SSQ-57A) Block Diagrams

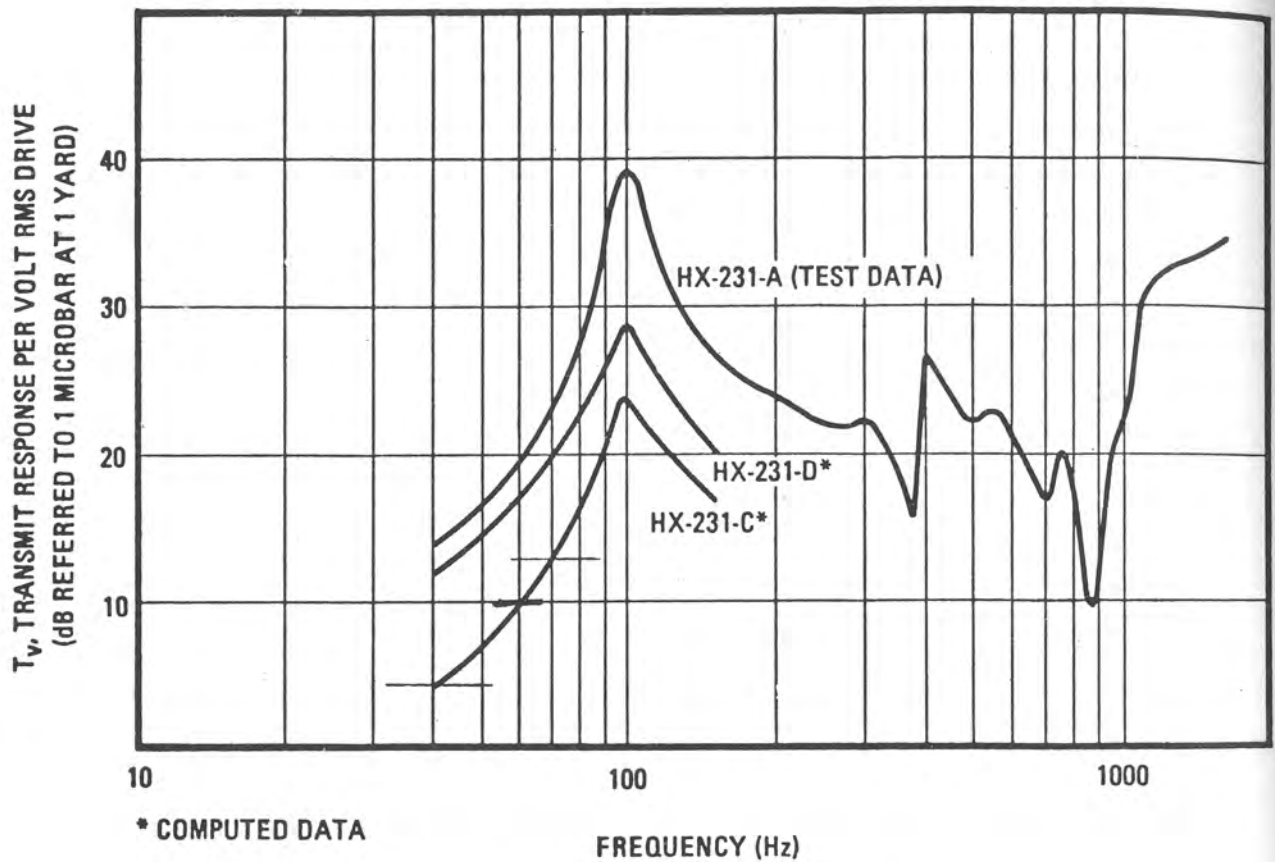
Figure 47

**TRANSMITTING RESPONSE,  
HX-231 SERIES**

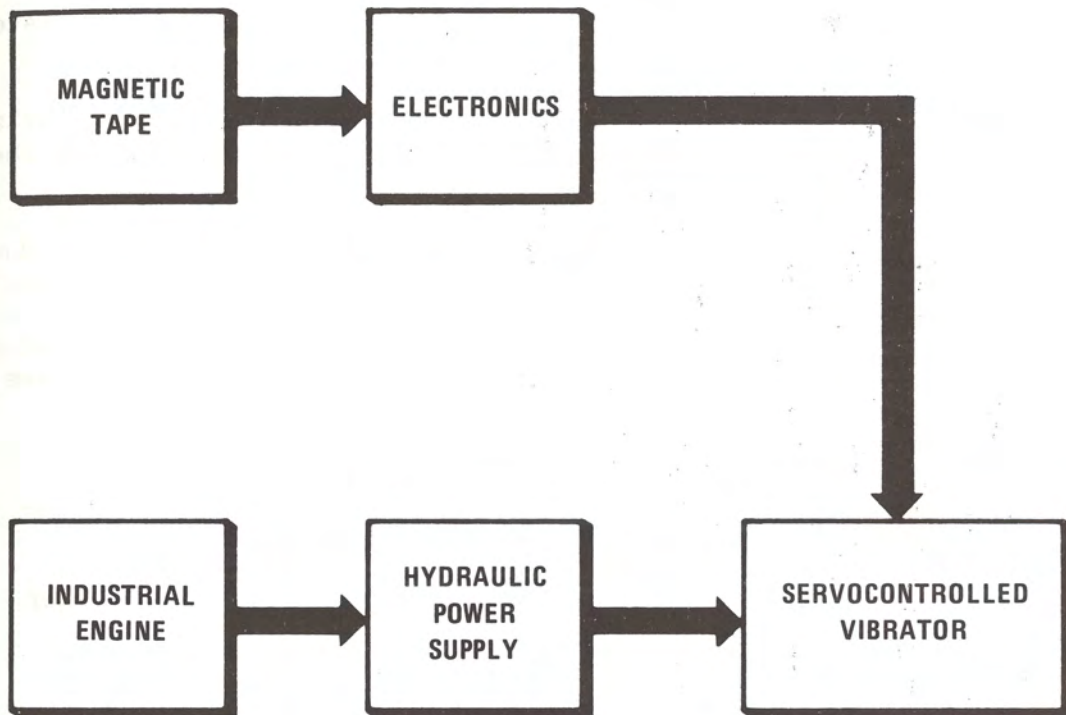
**BLOCK DIAGRAM OF  
VIBROSEIS ENERGY SOURCE**

The electronic system consists of modular units which contain circuits to process and control the feed back loops from the transducer itself. The basic input to the electronic system is the desired wave form and the system then is servoed to follow this wave form. The wave form can be any desired wave form in the 10 to 70 Hz range with degraded performance to 100 Hz. Suitable oscillators were provided to generate high quality sine waves in the desired range. A two channel oscilloscope was provided to monitor either the displacement of the transducer, which is physically related to the pressure wave developed, or to alternately monitor the hydrophones if desired. The received signal was retained on a permanent display device either in variable intensity or galvanometer mode. Figure 51 is a block diagram of the energy source.

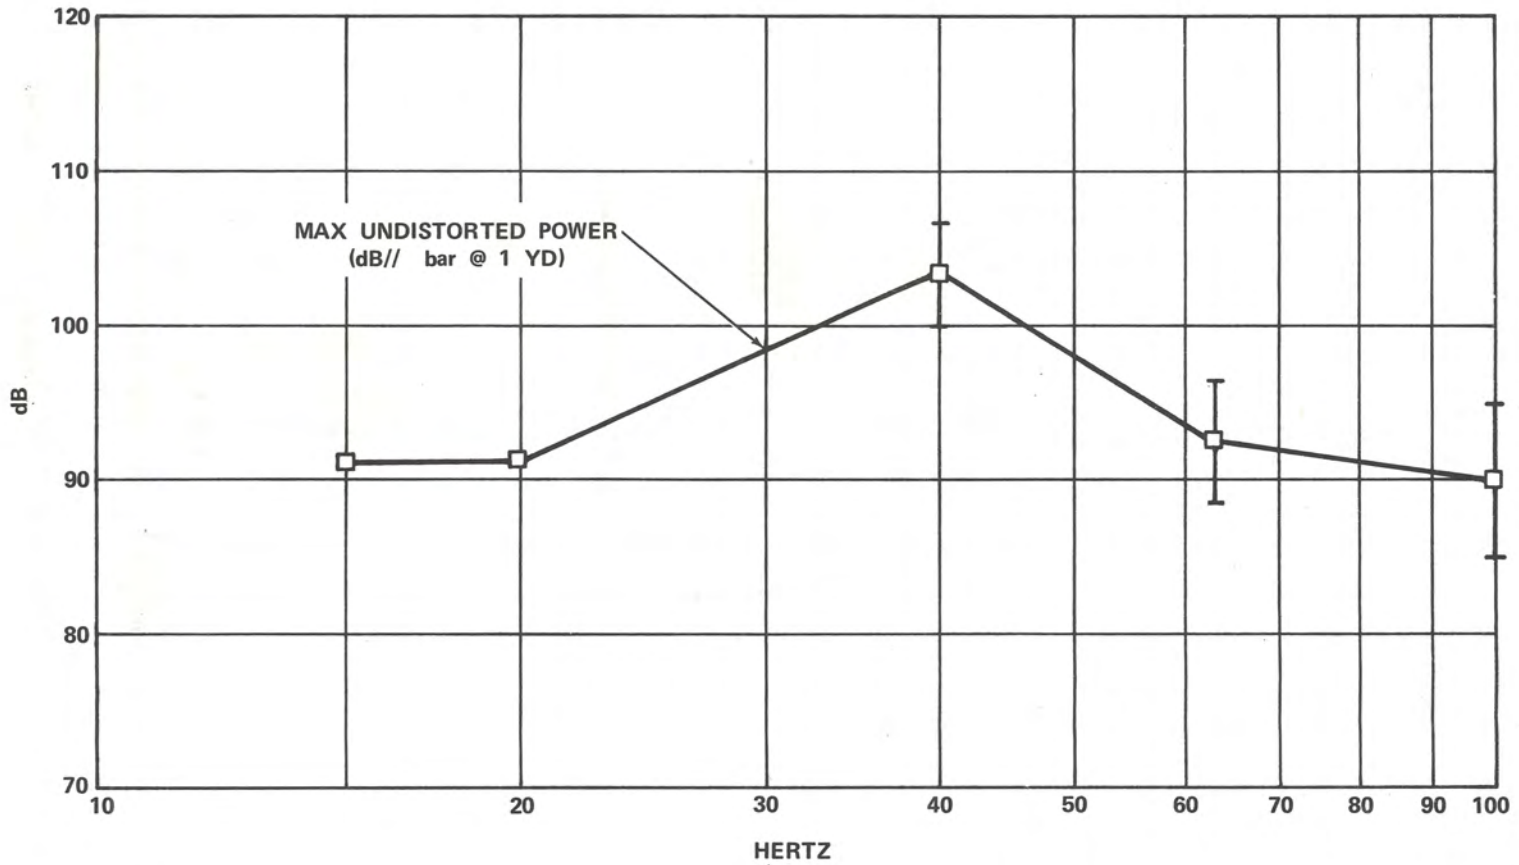
MAXIMUM UNDISTORTED SOURCE LEVEL

- (6). Figure 54 shows a peak acoustic level occurs at approximately 40 Hz although there is a lack of adjacent data points to confirm this. The peak level occurs in both the pulse and CW modes and is relatively independent of Mark IV operating depth. Delta believes this high level of operation is caused by an oil column resonance in the hydraulic valve.

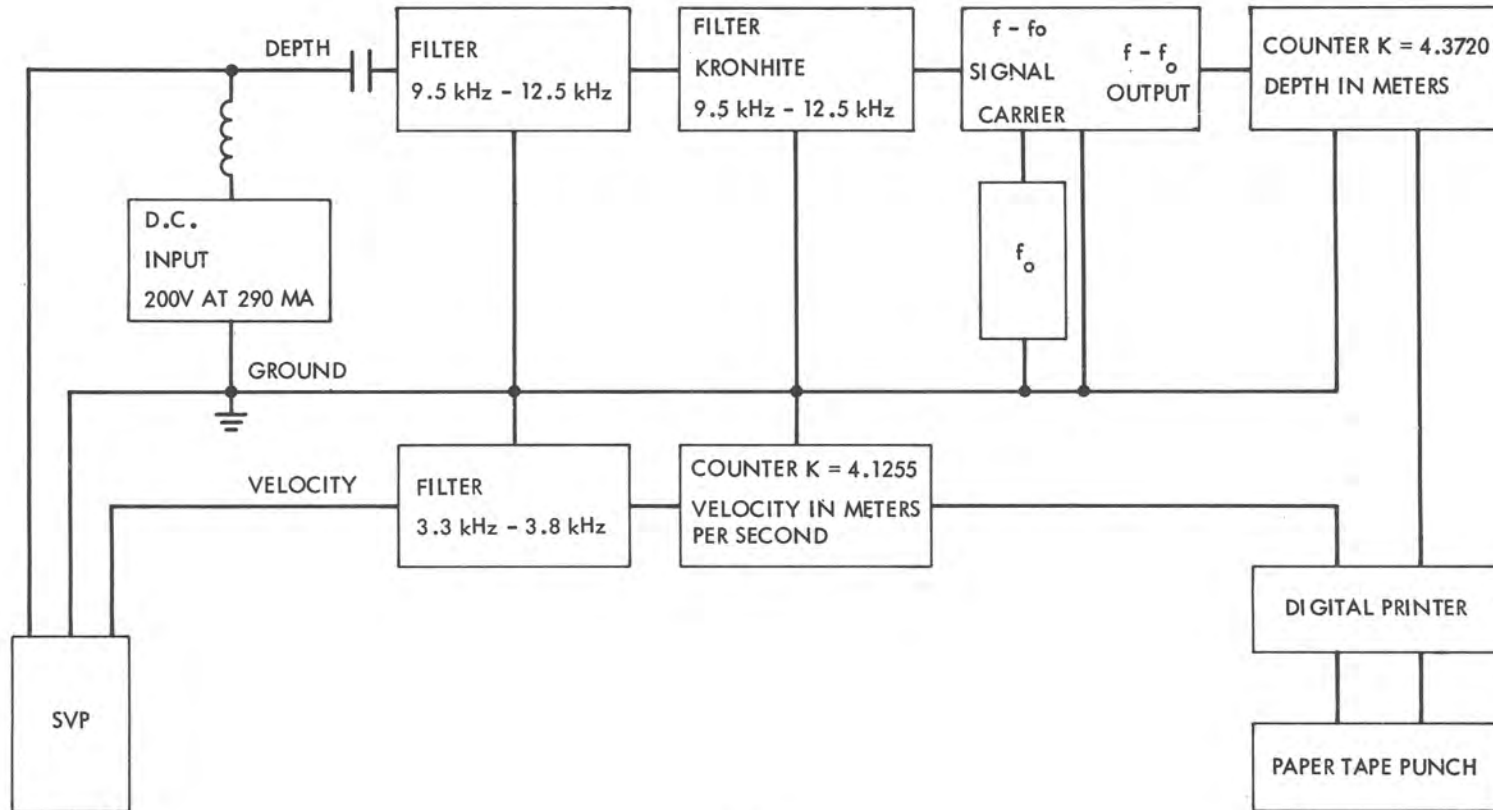
Figure 63

SANDS  
SVP BLOCK DIAGRAM

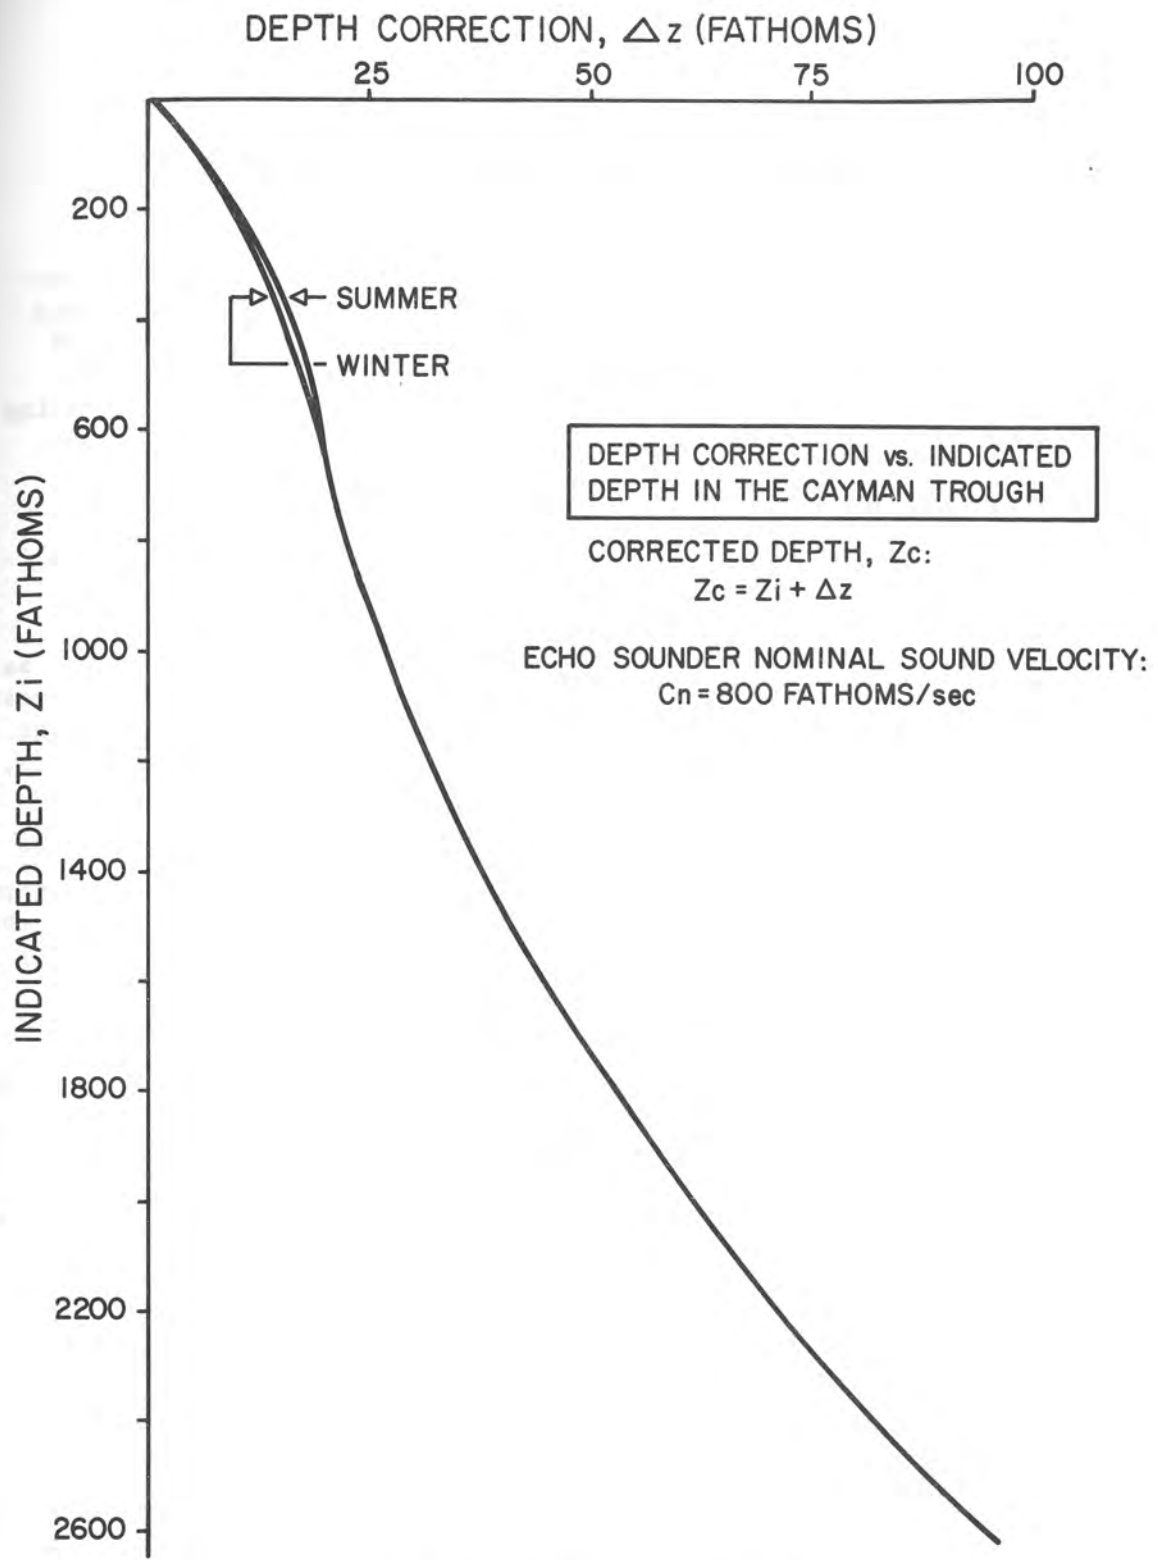
Figure 68

Echo Sounding Correction Chart  
( $C_n = 800$  fathoms/second)

However, for operational purposes it is often necessary to know the corrected depth. Figures 67 and 68 which plot depth correction based on historical average sound velocity profiles for the Cayman Trough area were found useful and agreed closely with the interpolated data from Matthews' Tables, Reference (13).
