**DAMAGE SURVEY AND RESTORATION OF M/V WELLWOOD
GROUNDING SITE, MOLASSES REEF,
KEY LARGO NATIONAL MARINE SANCTUARY, FLORIDA**

J. H. HUDSON and R. DIAZ

U. S. Geological Survey, Fisher Island Station,
Miami Beach, Florida USA 33139

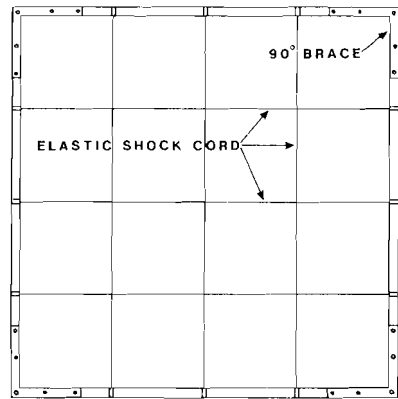
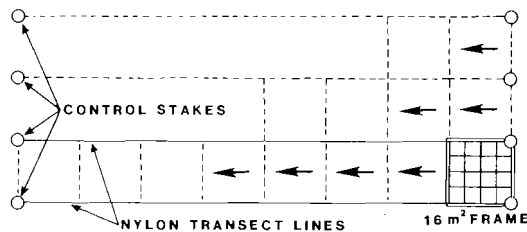
16 m² ALUMINUM SEARCH FRAME

Figure 2. Drawing of 16-m² aluminum search frame and diagrammatic sketch of survey procedure using frame.
