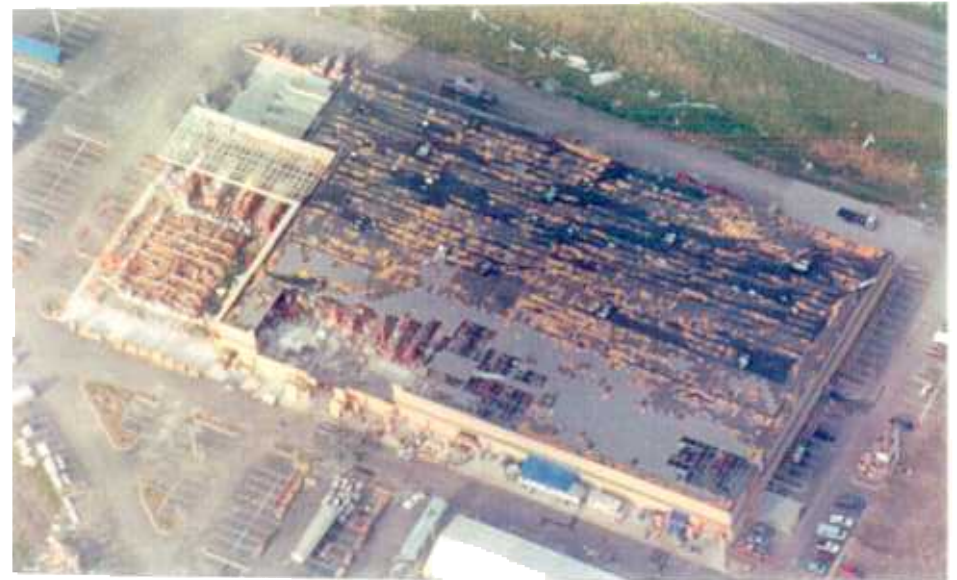
4. Loss of metal roof deck above department store entrance and northeast corner along Highway 1. View looking west.

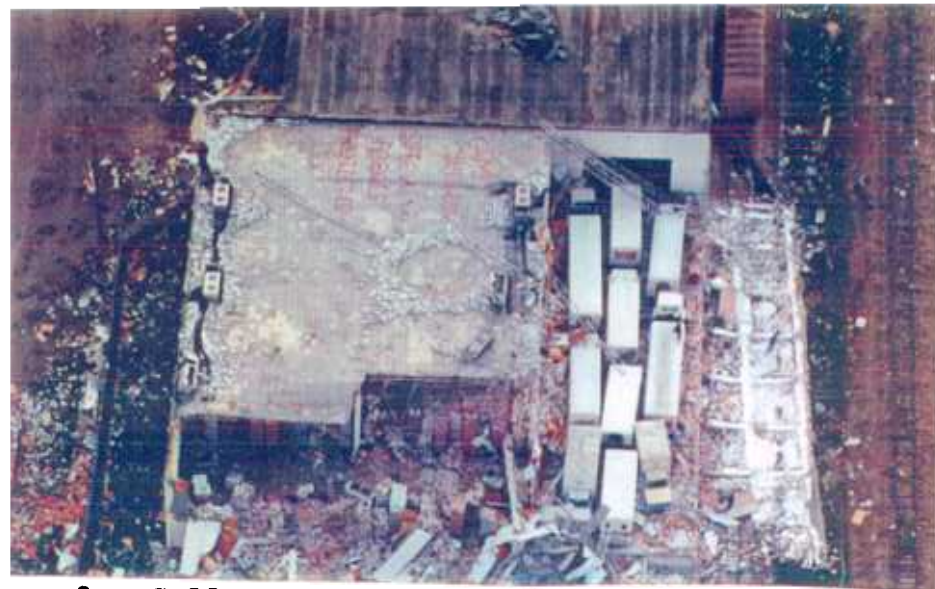
8. Collapsed north and west walls of  
concrete masonry building housing Budweiser  
Distributing.

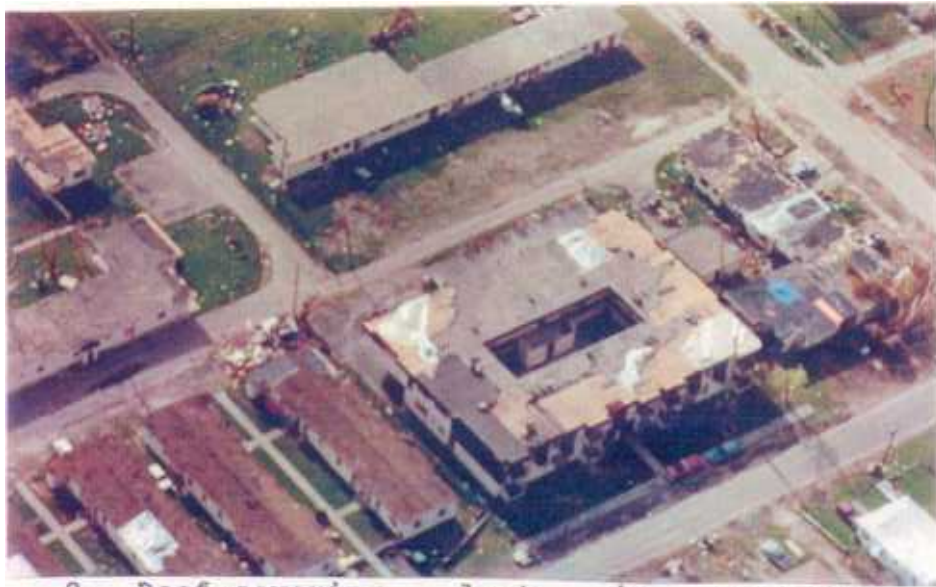
9. Roof covering lost in opposite directions on Florida City apartment building (looking southeast).

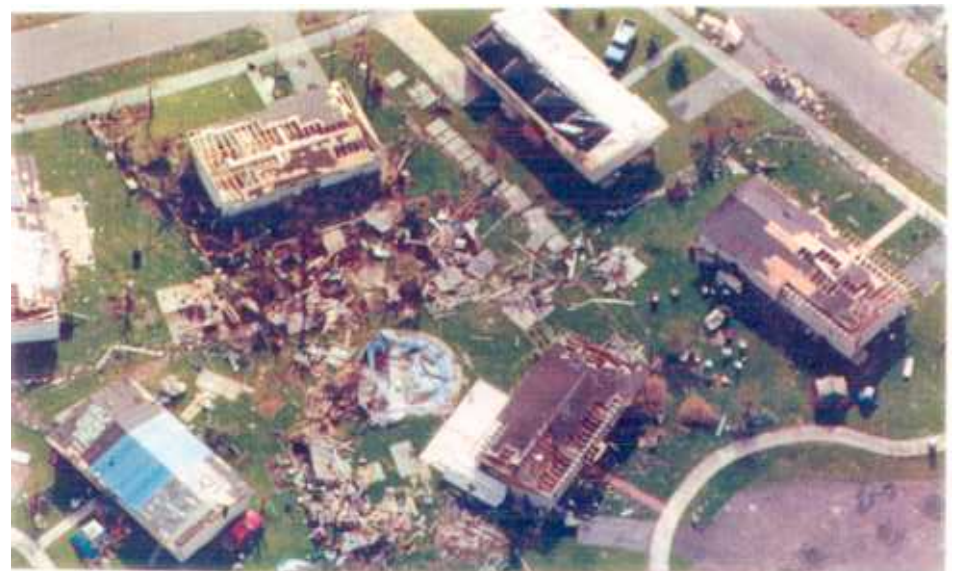
16. Removal of roof deck exposed wooden trusses on concrete masonry homes in Florida City.

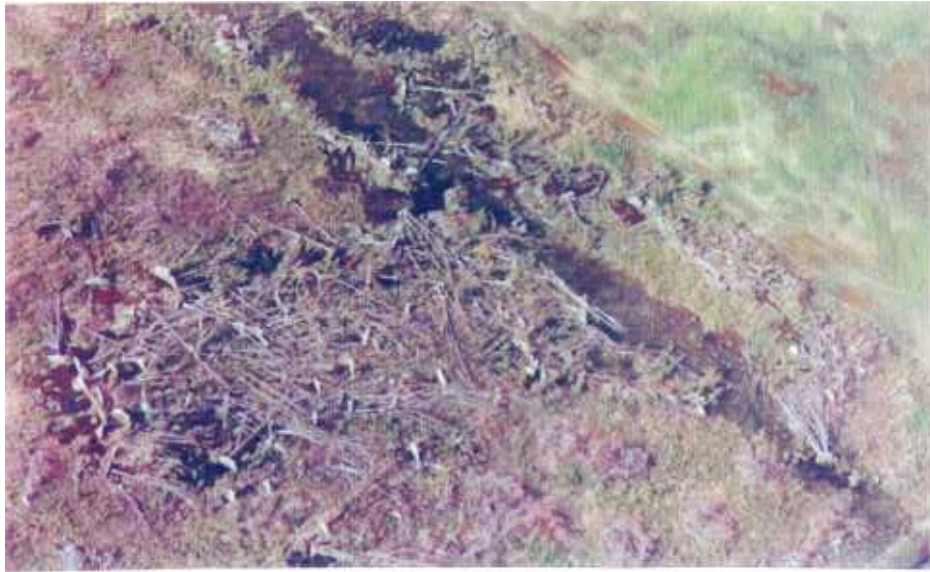
21. Tree falls in various directions just south of Florida City. View looking southwest.

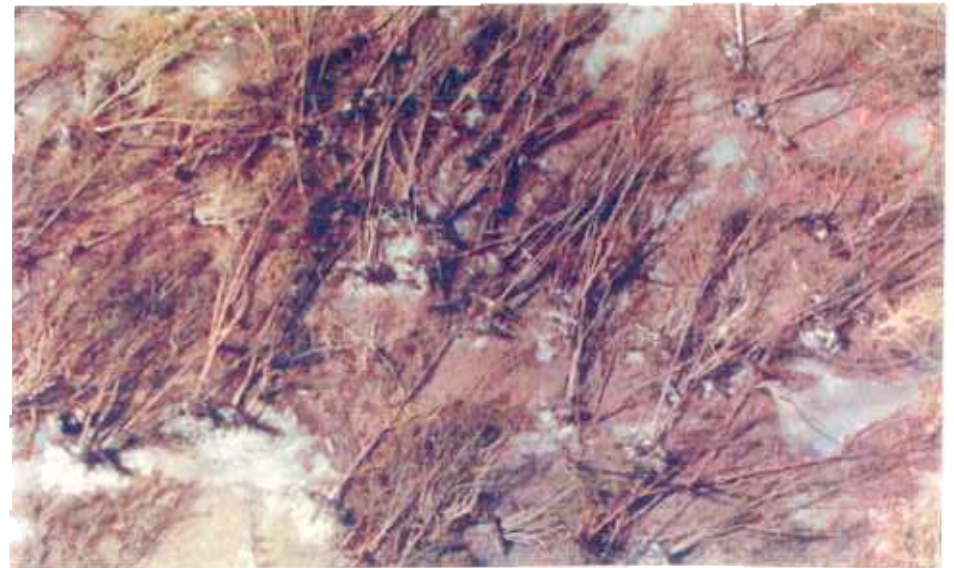
28. Close-up view of flattened forest at south end of Key Biscayne. Downed trees pointed due west.

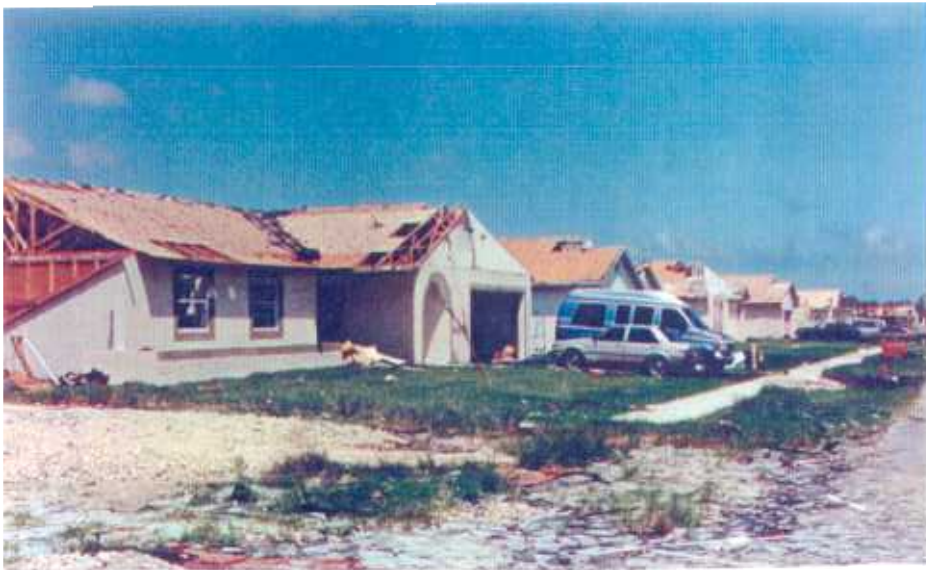
33. Almost complete absence of composition shingles on each house in subdivision just west of Homestead Air Force Base.

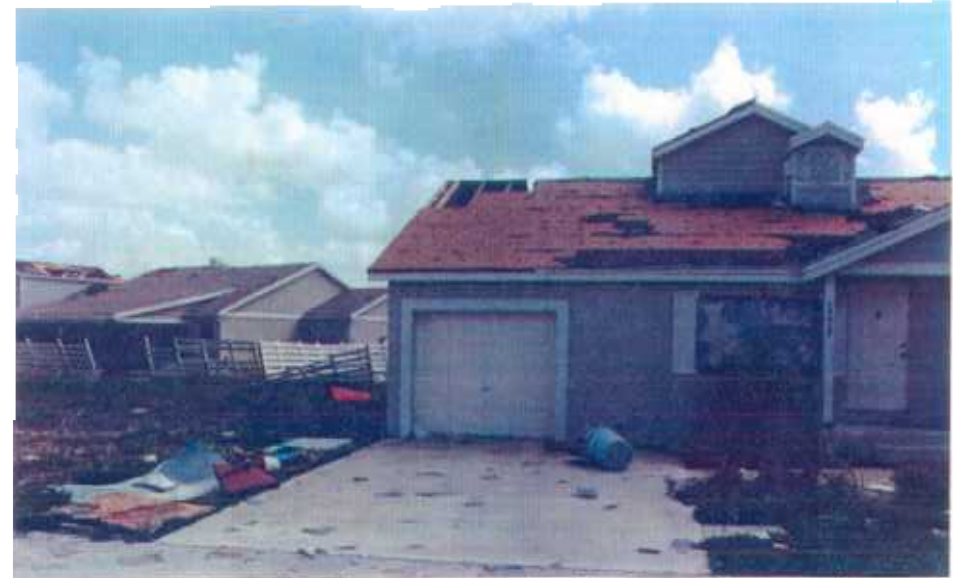
34. Roof shingles were stapled on house to the right and nailed on the house to the left (Country Walk).

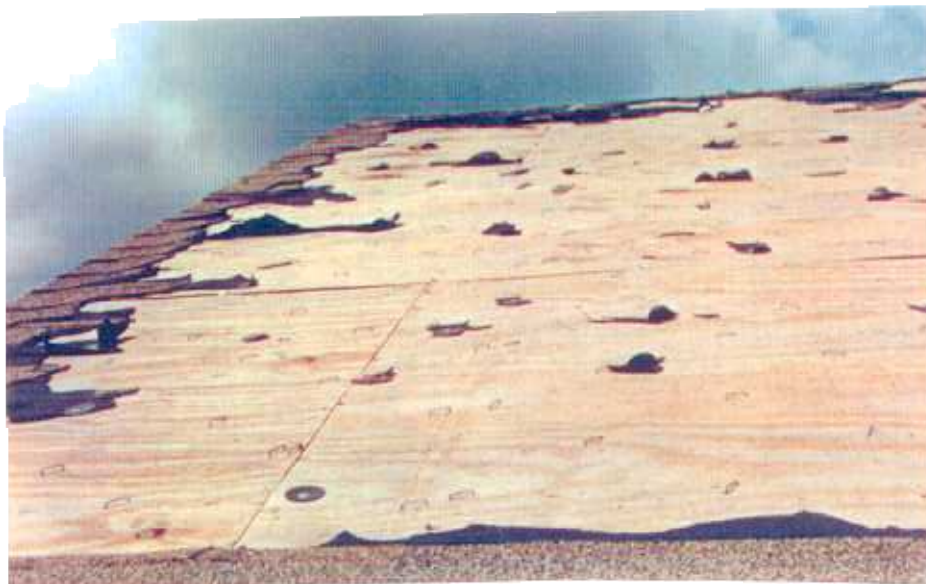
35. Close-up roof view showing staples secured in plywood deck. Many staples are crooked and oriented incorrectly.

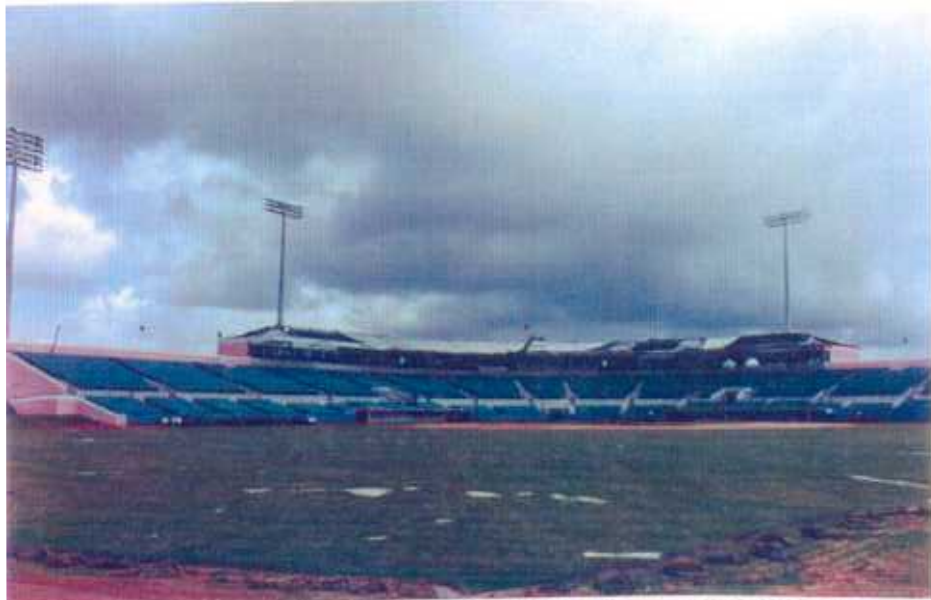
57. Cleveland Indians stadium in Homestead Florida. Light standards remained upright.

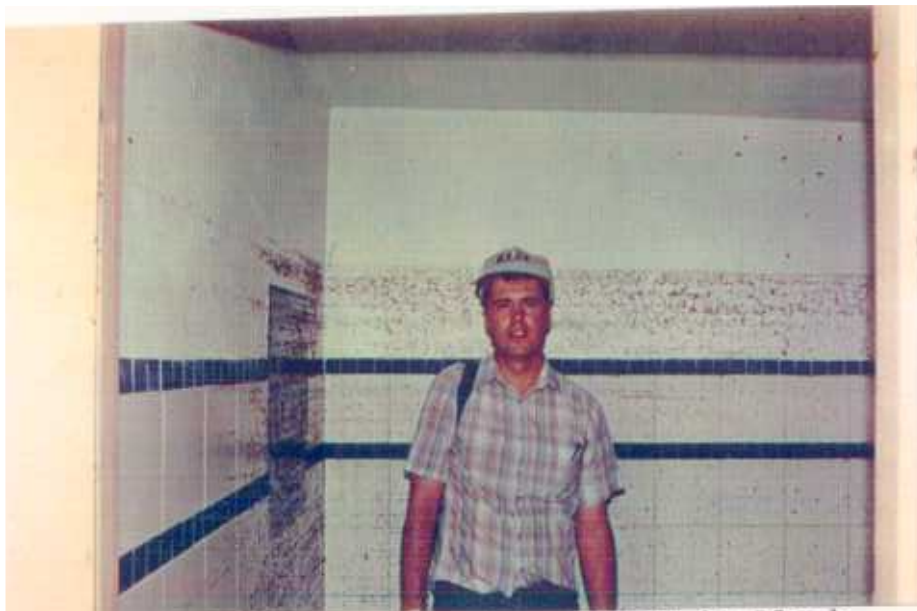
71. Water mark along restroom wall in Black Point Marina.
