# RADAR PREFLIGHT CHECKLIST

FLIGHT # 19800805I1 - RADAR AUG 5 1980

A.C. # 43RF

AUG 5 1980 NHEML RADAR TAPE LOG

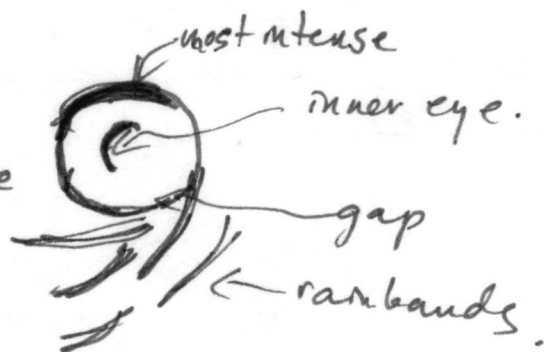
114555 eyewall has

upside down Coma or "6" structure

~~South~~ during penetration of south side of outer eyewall  
good nose data

"eyewall looks like a hexagon" B. Lewis

115020 rainbands prevalent bearing 240-330°

20-60 nmi.

weak area of eyewall moving

toward NE side of storm

peak wind stronger on north side

south side peak wind ~100 Kts

rainbands on east <sup>side</sup> of storm moving toward  
NE quadrant feeding into strong region  
to North.

inner eye has half  
moon structure
