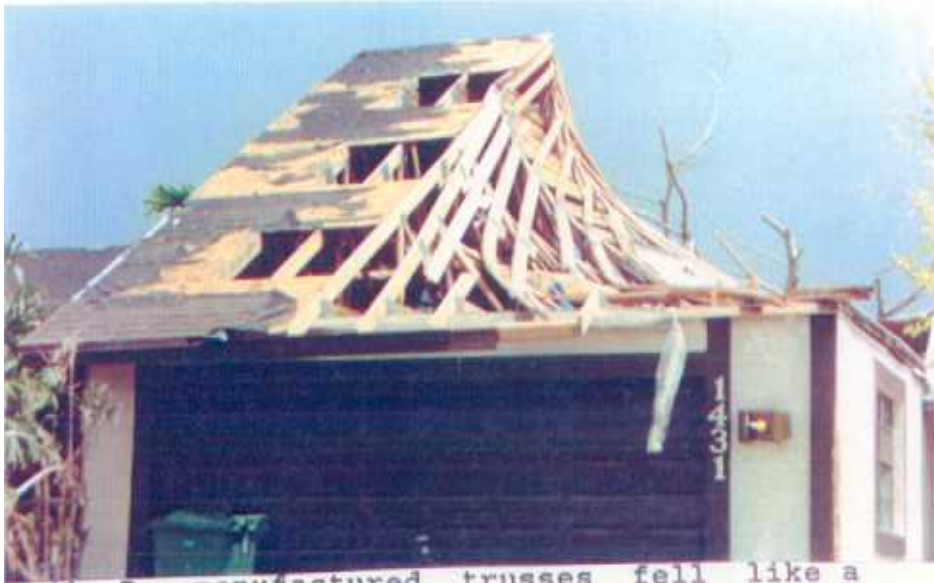
41. Pre-manufactured trusses fell like a stack of dominoes as they were laterally braced only by roof decking.

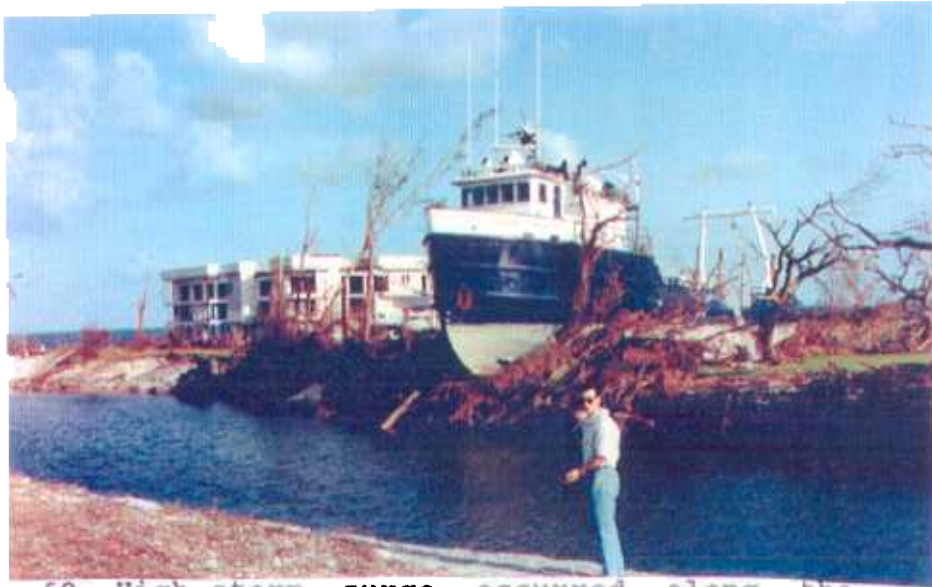
69. High storm surge occurred along the Cutler Canal where a large boat was washed ashore.
